# the **play inspection** company

## Annual Inspection

Mid Suffolk District Council

Coddenham

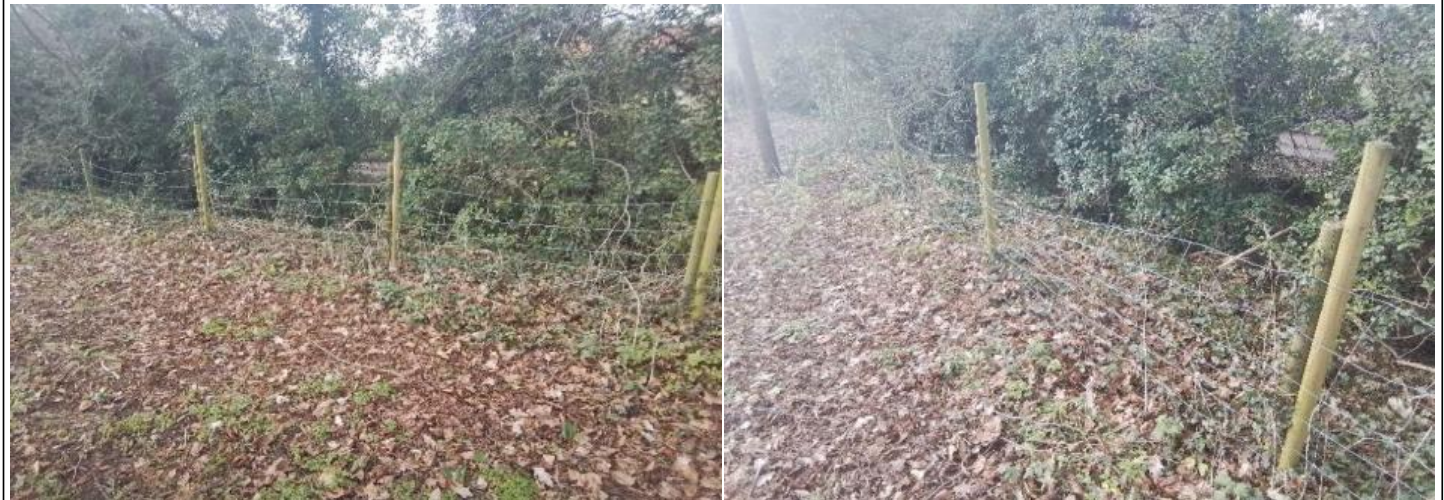
There is some damage to the fence sections - Monitor for any further deterioration and repair as required

<b>Finding:</b> There is some damage to the fence sections	<b>Action:</b> Monitor for any further deterioration and repair as required
--	---

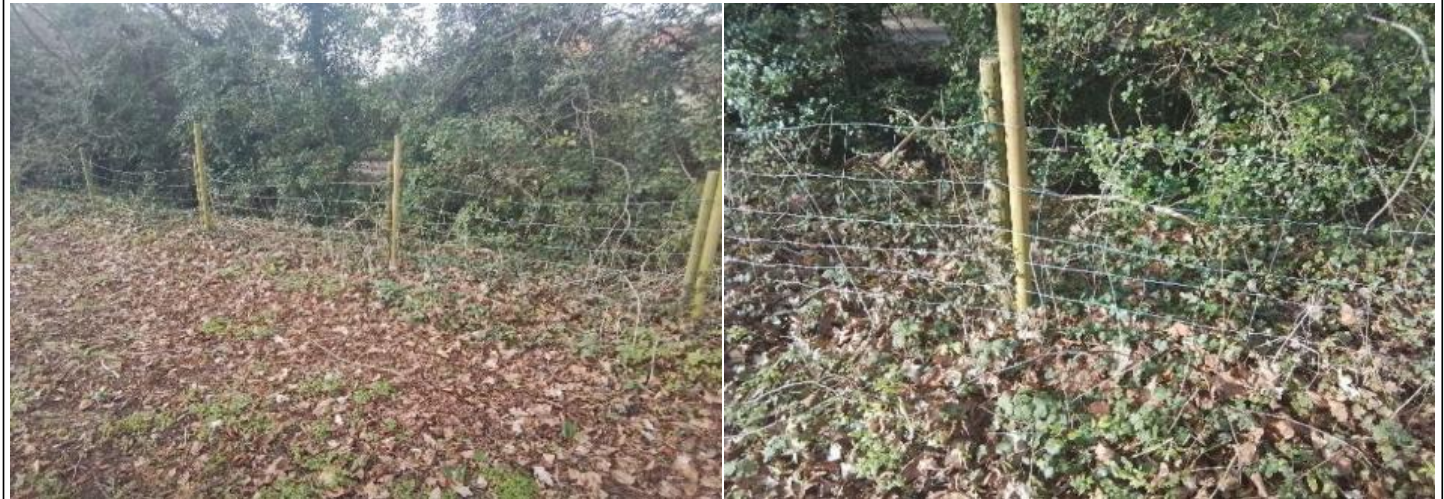
There are a number of loose posts around the fence - Reset as required

<b>Finding:</b> There are a number of loose posts around the fence	<b>Action:</b> Reset as required
--	----------------------------------

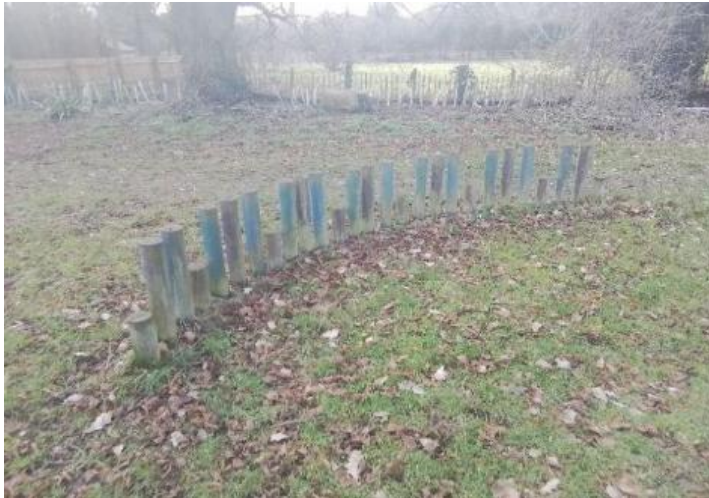
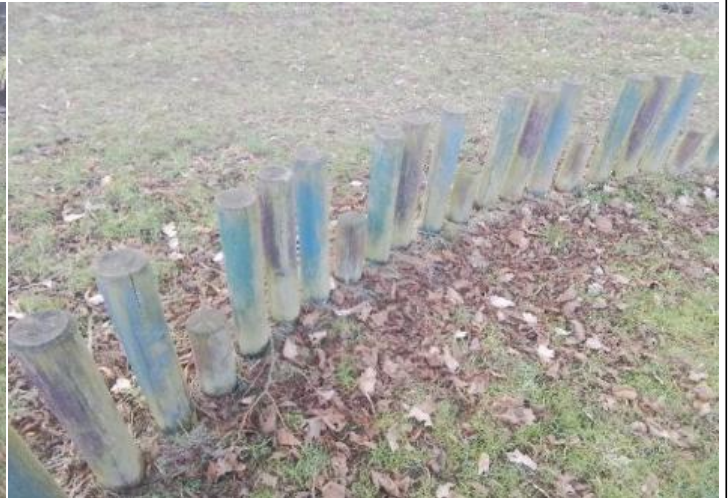
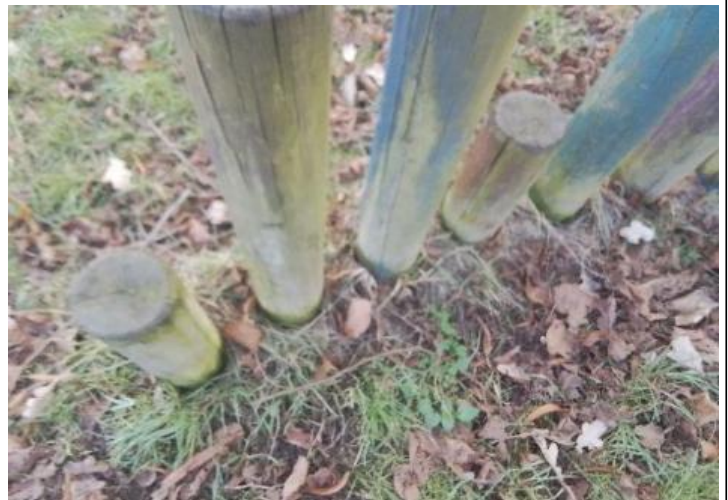
There are areas or parts of the timber on the structure that have rotted - Replace all affected timbers

**Finding:** There are areas or parts of the timber on the structure that have rotted

**Action:** Replace all affected timbers

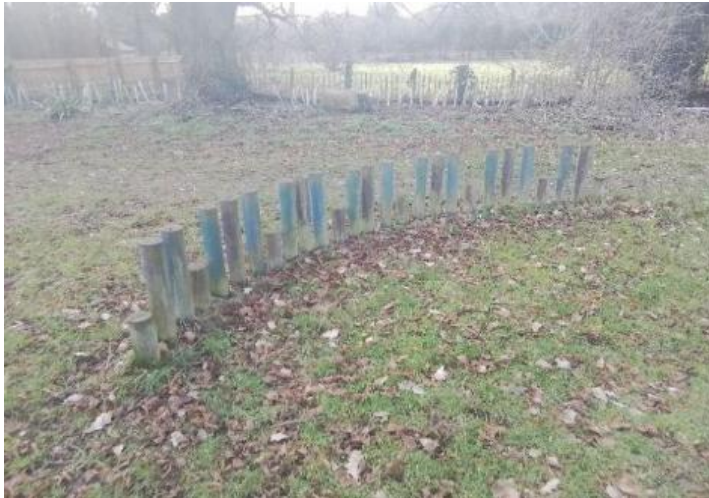
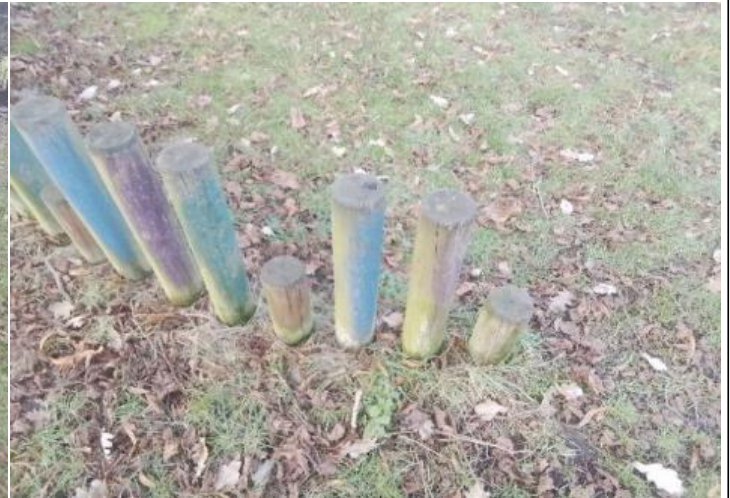
The item is slightly loose in its foundations - Monitor for any further deterioration and repair as required

**Finding:** The item is slightly loose in its foundations

**Action:** Monitor for any further deterioration and repair as required

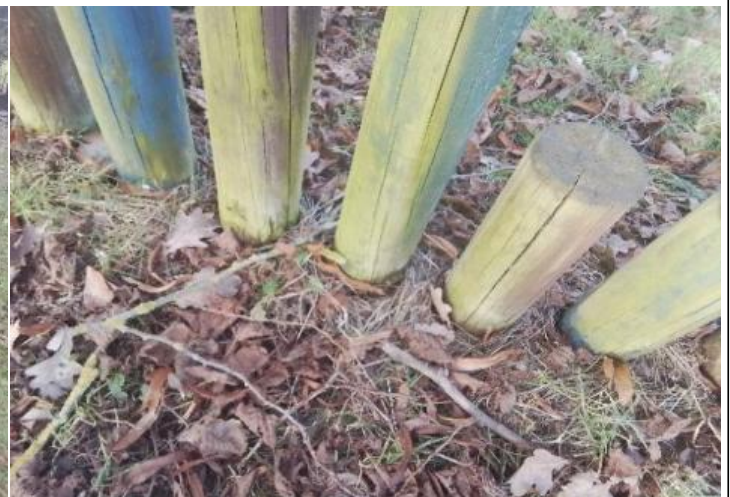
There is some strimmer / machinery damage apparent on the posts, this can penetrate the preservative applied to the timber and accelerate the rotting process - Monitor for any deterioration (rot) and replace as required

**Finding:** There is some strimmer / machinery damage apparent on the posts, this can penetrate the preservative applied to the timber and accelerate the rotting process

**Action:** Monitor for any deterioration (rot) and replace as required

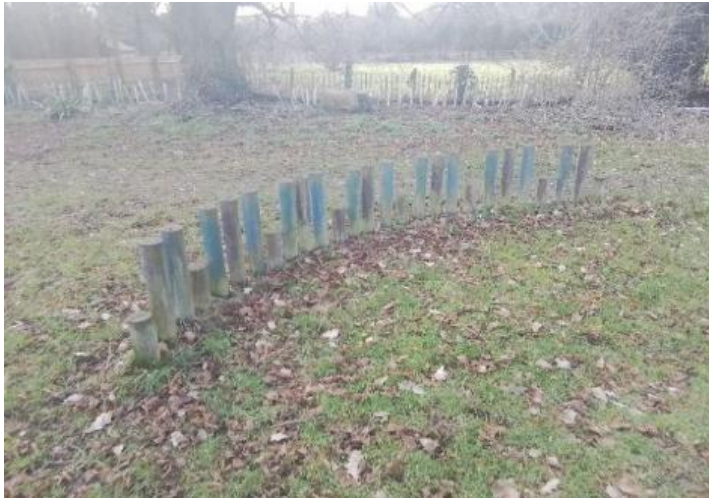
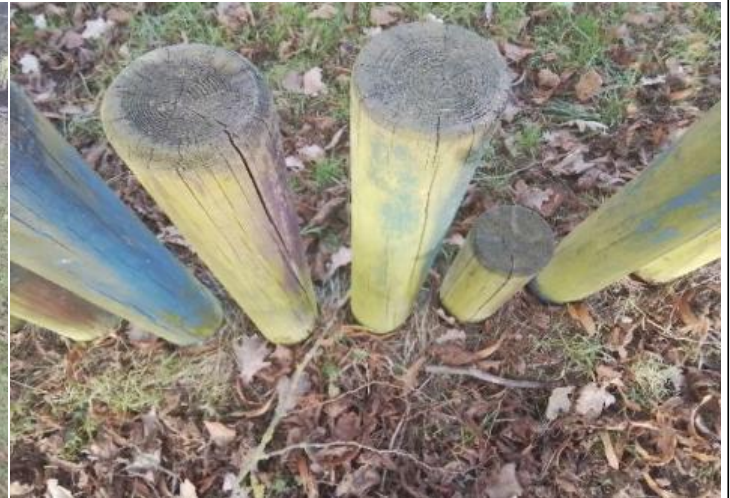
The timber has a number of splits/shakes or air cracks and this may affect the stability or allow water ingress which will accelerate the rotting process - Monitor to ensure the splits do not cross through fixing points of the structure and/or cause any instability

**Finding:** The timber has a number of splits/shakes or air cracks and this may affect the stability or allow water ingress which will accelerate the rotting process  
**Action:** Monitor to ensure the splits do not cross through fixing points of the structure and/or cause any instability

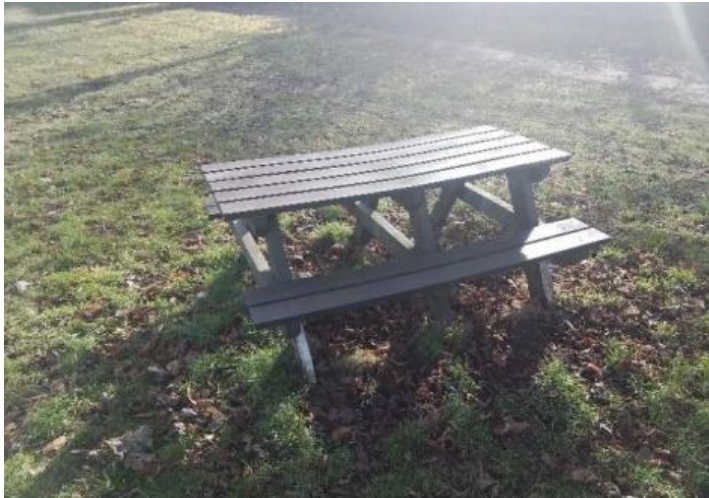
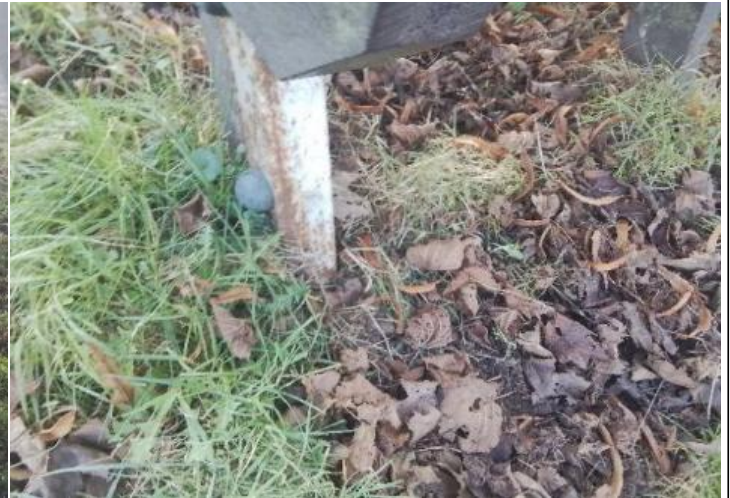
The paintwork on this item has been damaged or worn exposing the metal underneath which is rusting - Treat any rusting components and repaint

**Finding:** The paintwork on this item has been damaged or worn exposing the metal underneath which is rusting

**Action:** Treat any rusting components and repaint

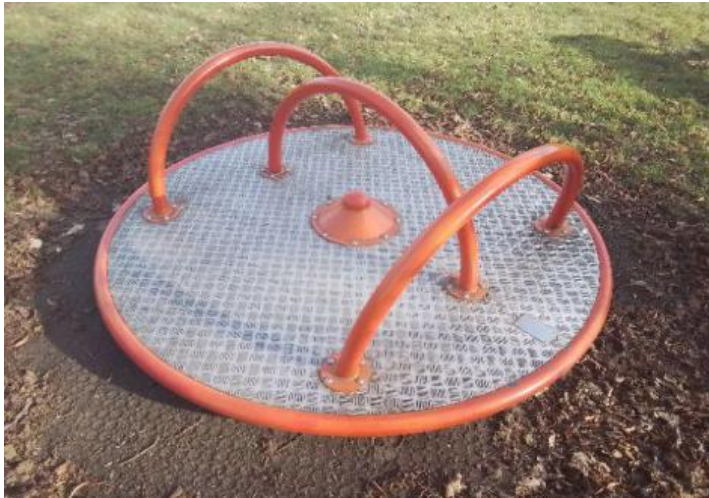
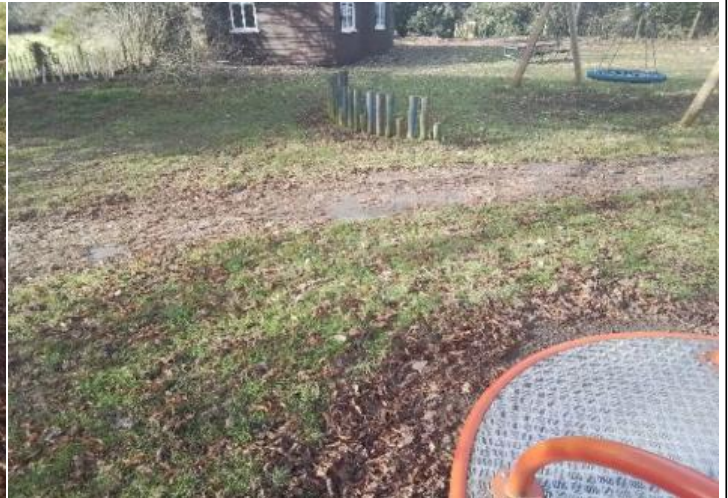
The surfacing dimensions are short and do not meet with the requirements of the current applicable standard -  
 Monitor - no remedial action recommended

**Finding:** The surfacing dimensions are short and do not meet with the requirements of the current applicable standard

**Action:** Monitor - no remedial action recommended

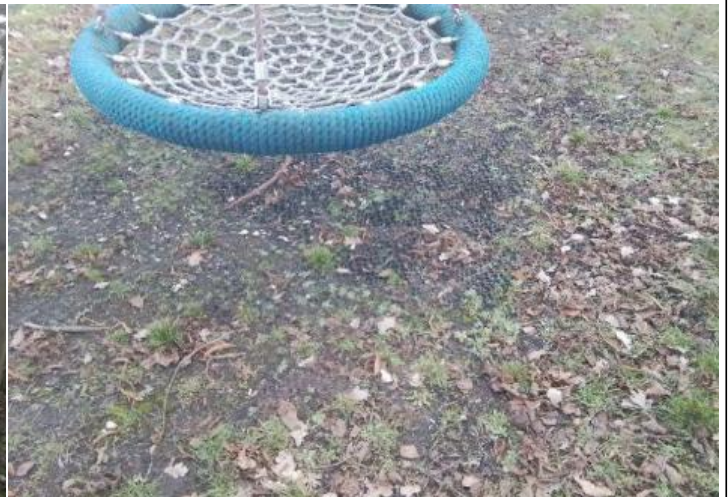
The surface has subsided in some areas - Monitor for any further deterioration and repair as required

**Finding:** The surface has subsided in some areas

**Action:** Monitor for any further deterioration and repair as required

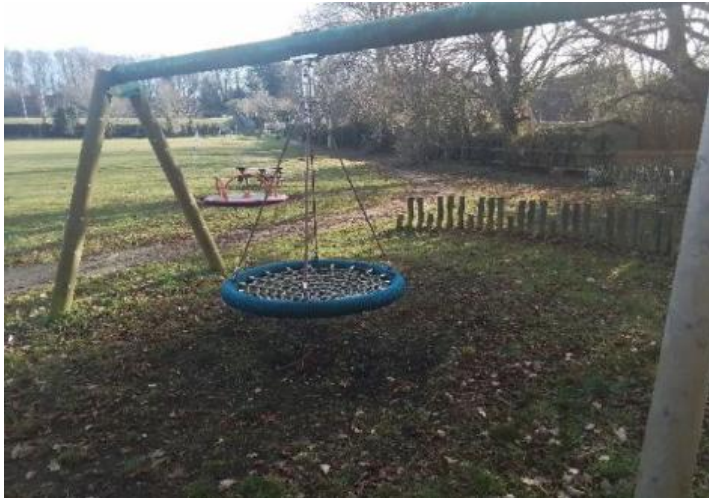
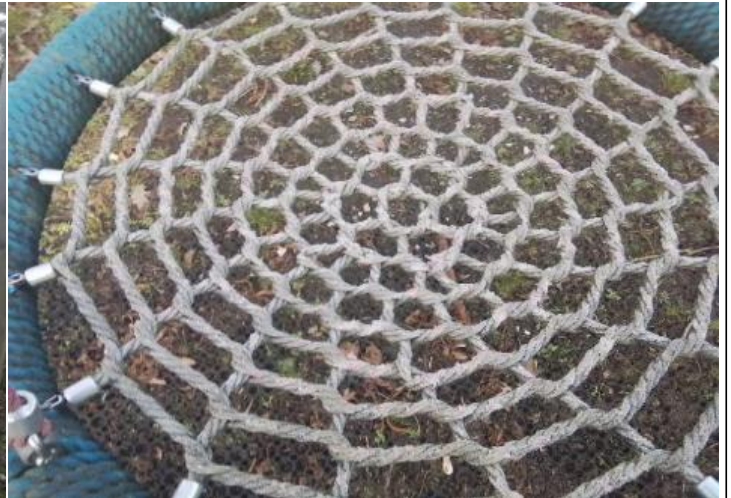
The ropes/nets are worn/damaged in places - Monitor for any further deterioration and repair or replace as required

**Finding:** The ropes/nets are worn/damaged in places

**Action:** Monitor for any further deterioration and repair or replace as required

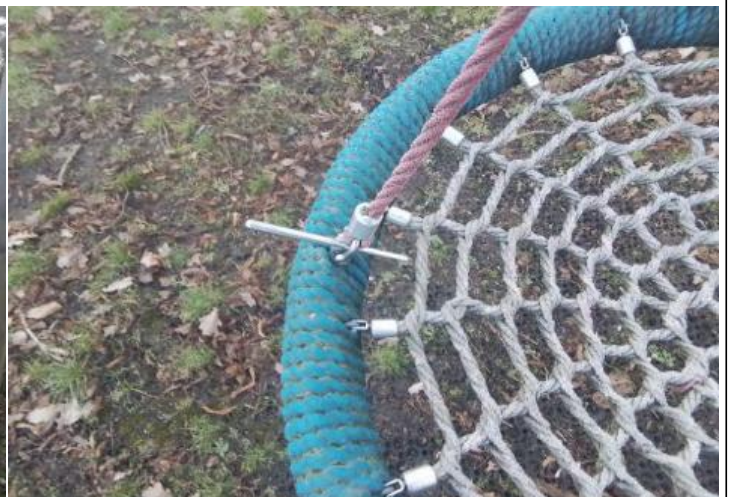
The connecting links are in excess of 8.6mm and less than 12mm and fail the requirements of BS EN 1176 Part 1; clause 4.2.13, Chains - Monitor use and replace with compliant links at the next maintenance cycle

**Finding:** The connecting links are in excess of 8.6mm and less than 12mm and fail the requirements of BS EN 1176 Part 1; clause 4.2.13, Chains

**Action:** Monitor use and replace with compliant links at the next maintenance cycle

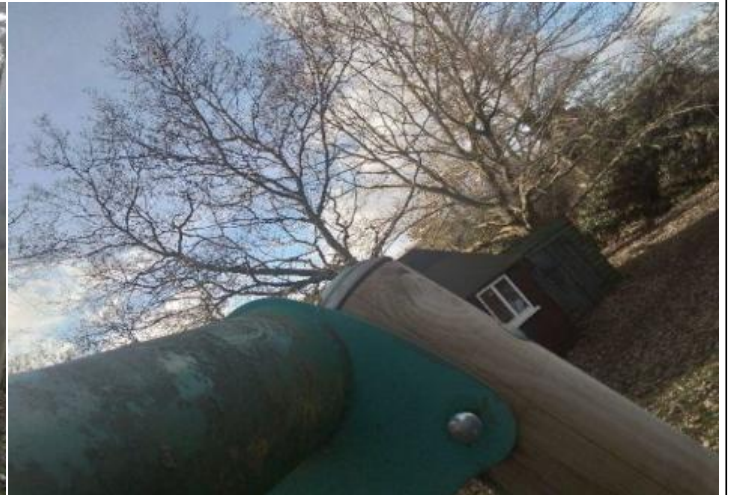
A number of fixing(s) have worked loose - Secure all loose fixings

**Finding:** A number of fixing(s) have worked loose

**Action:** Secure all loose fixings

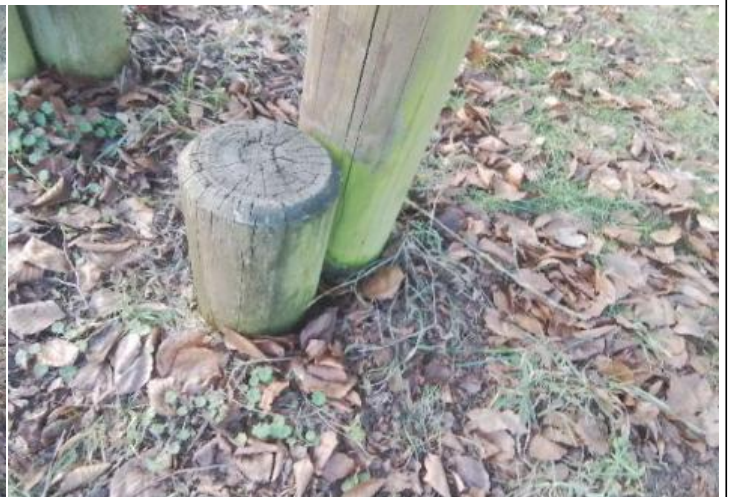
There is some strimmer / machinery damage apparent on the posts, this can penetrate the preservative applied to the timber and accelerate the rotting process - Monitor for any deterioration (rot) and replace as required

**Finding:** There is some strimmer / machinery damage apparent on the posts, this can penetrate the preservative applied to the timber and accelerate the rotting process

**Action:** Monitor for any deterioration (rot) and replace as required

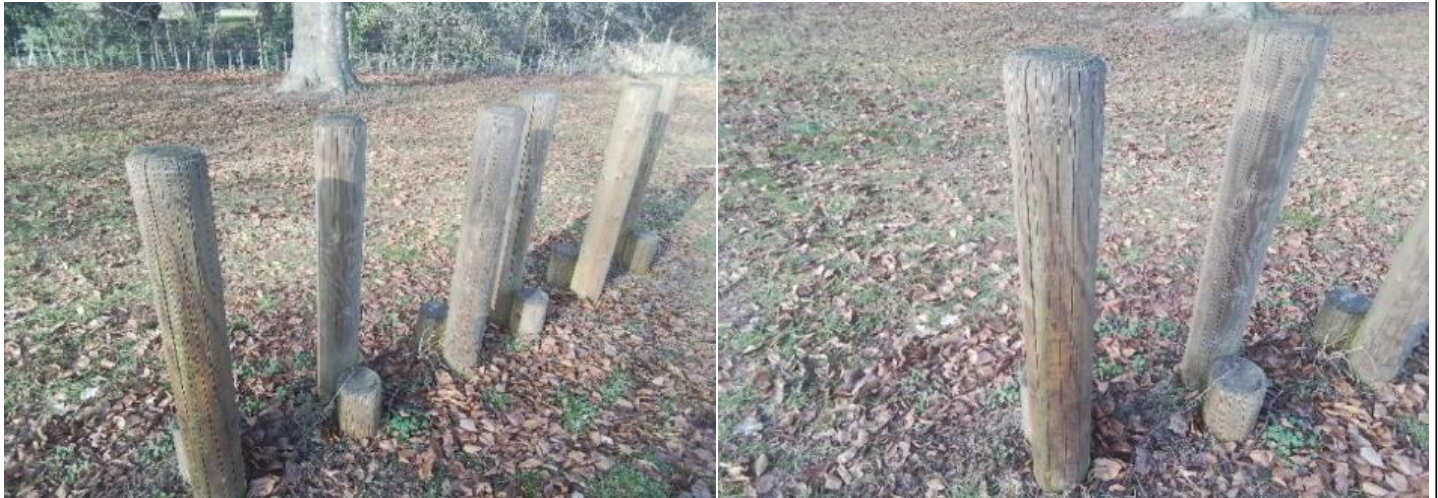
The timber has a number of splits/shakes or air cracks and this may affect the stability or allow water ingress which will accelerate the rotting process - Monitor to ensure the splits do not cross through fixing points of the structure and/or cause any instability

**Finding:** The timber has a number of splits/shakes or air cracks and this may affect the stability or allow water ingress fixing points of the structure and/or cause any instability which will accelerate the rotting process

**Action:** Monitor to ensure the splits do not cross through

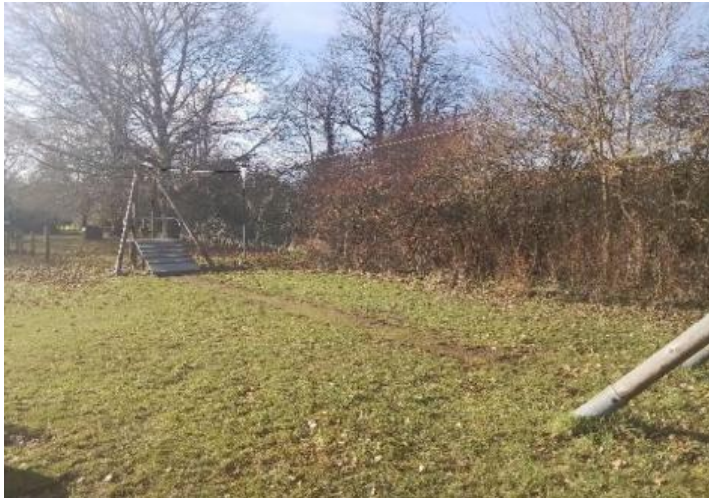
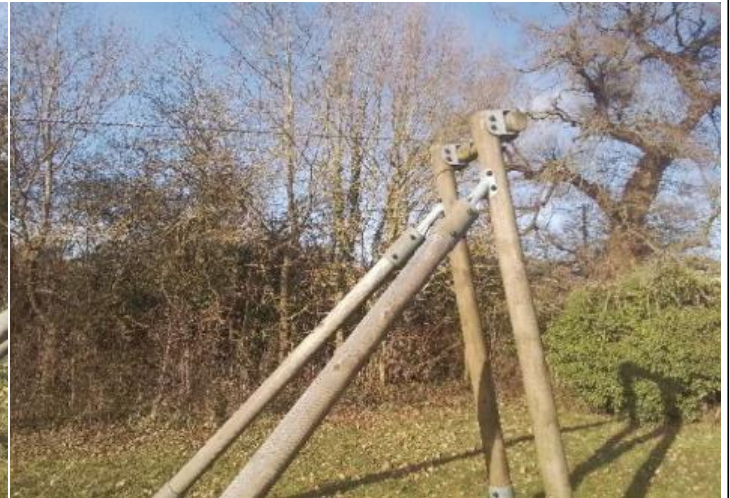
We have completed a visual inspection of the suspension links, cable and fixing points from ground level, however it is not possible to fully inspect these areas without either hiring equipment to gain access or removing the cable and suspension and inspecting at ground level. We recommend that the main cable and fixing security is thoroughly inspected at least in accordance with the manufacturers recommendations to check for wear, damage, security or internal rusting; this will help to ensure the continued safe use of the equipment - Inspect in accordance with the manufacturers recommendations

**Finding:** We have completed a visual inspection of the suspension links, cable and fixing points from ground level, however it is not possible to fully inspect these areas without either hiring equipment to gain access or removing the cable and suspension and inspecting at ground level. We recommend that the main cable and fixing security is thoroughly inspected at least in accordance with the manufacturers recommendations to check for wear, damage, security or internal rusting; this will help to ensure the continued safe use of the equipment

**Action:** Inspect in accordance with the manufacturers recommendations

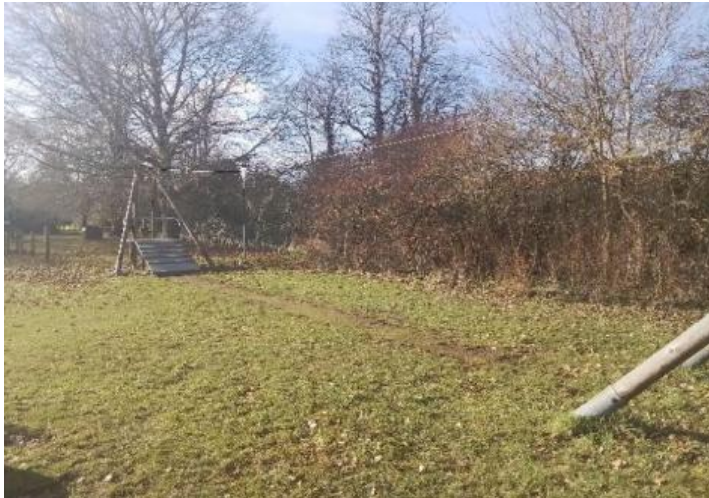
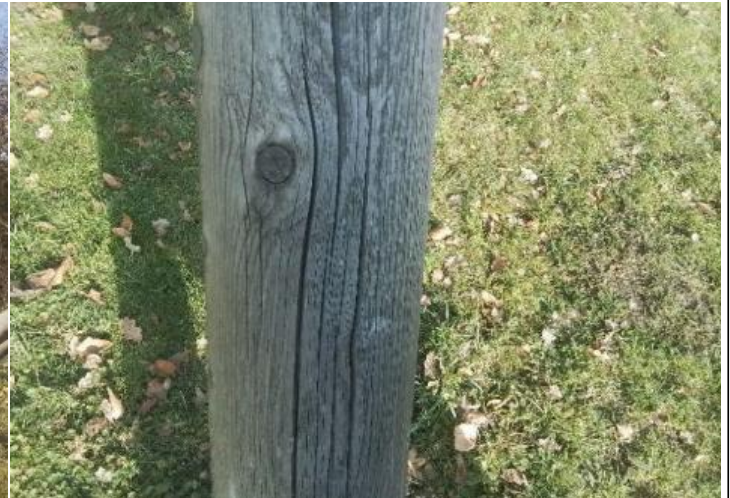
The timber has a number of splits/shakes or air cracks and this may affect the stability or allow water ingress which will accelerate the rotting process - Monitor to ensure the splits do not cross through fixing points of the structure and/or cause any instability

**Finding:** The timber has a number of splits/shakes or air cracks and this may affect the stability or allow water ingress which will accelerate the rotting process  
**Action:** Monitor to ensure the splits do not cross through fixing points of the structure and/or cause any instability

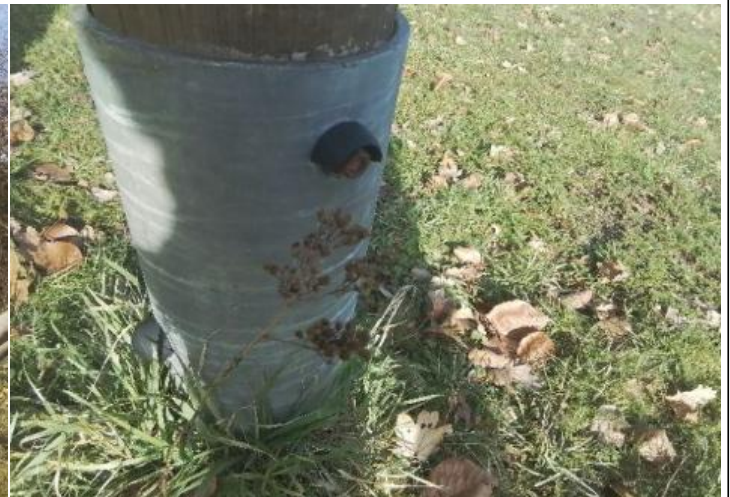
There is/are bolt cap covers missing or damaged on the item - Replace missing or damaged bolt cap covers

**Finding:** There is/are bolt cap covers missing or damaged on the item  
**Action:** Replace missing or damaged bolt cap covers

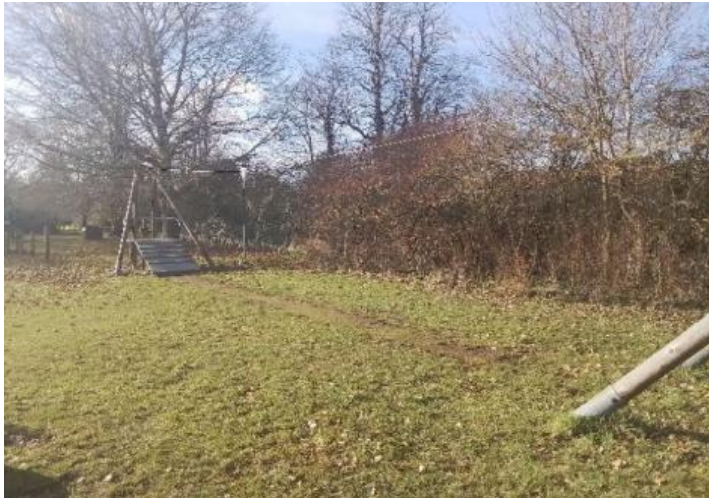
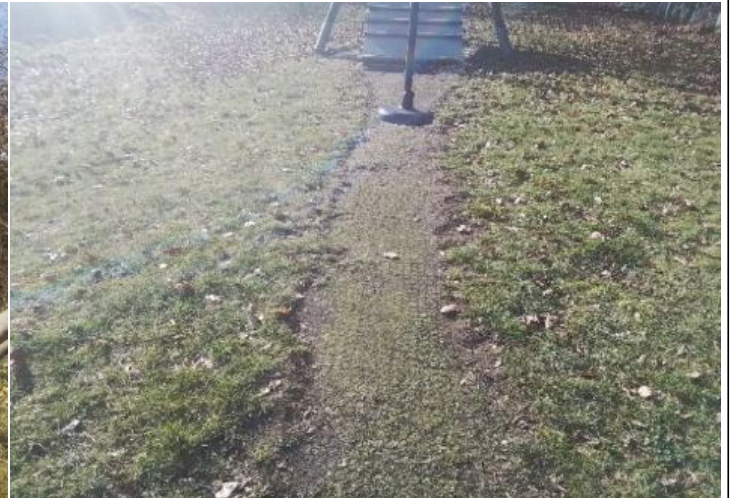
The grass mats are silted up and the soil is compacted; this may have an effect on the impact absorbing properties of the surface - Consider HIC testing impact absorbing properties to ensure the correct surface qualities are maintained for the equipment and replace as required

**Finding:** The grass mats are silted up and the soil is compacted; this may have an effect on the impact absorbing properties of the surface

**Action:** Consider HIC testing impact absorbing properties to ensure the correct surface qualities are maintained for the equipment and replace as required

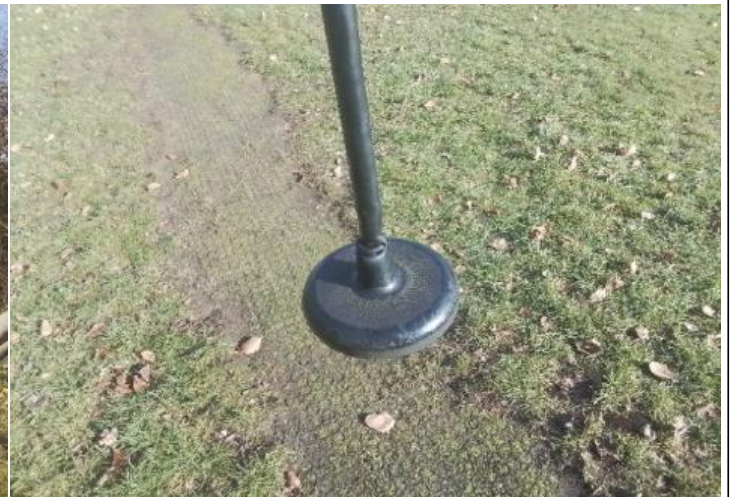
The seat connection cannot be inspected without dismantling the seat - Dismantle the seat to inspect the seat connection for wear

**Finding:** The seat connection cannot be inspected without dismantling the seat

**Action:** Dismantle the seat to inspect the seat connection for wear

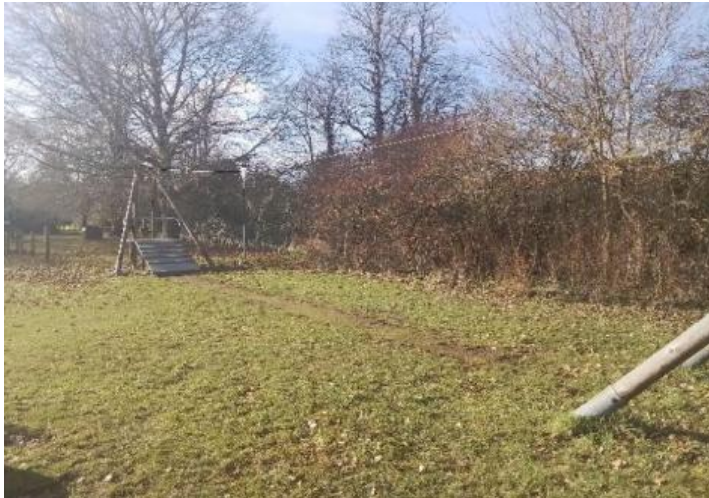
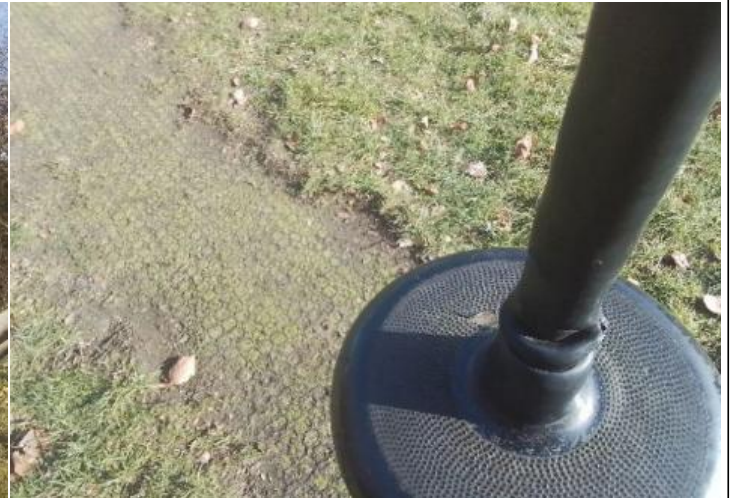
The seat suspension cover has been damaged - Monitor for any further deterioration and replace as required

**Finding:** The seat suspension cover has been damaged

**Action:** Monitor for any further deterioration and replace as required

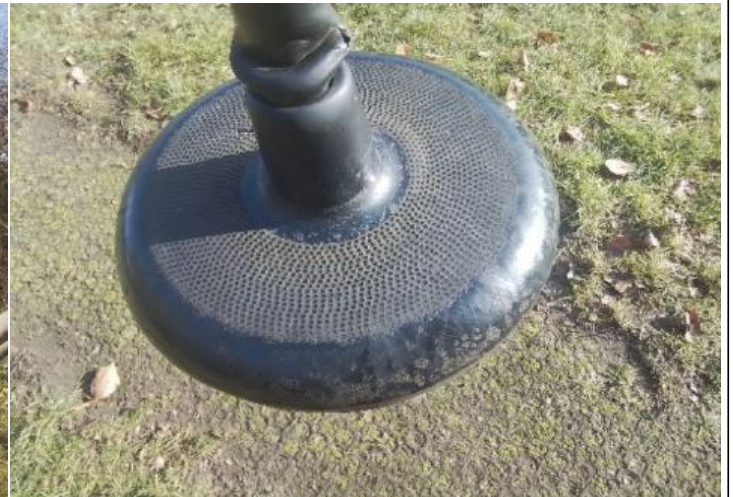
The cableway seat has been damaged - Monitor for any further deterioration and replace as required

**Finding:** The cableway seat has been damaged

**Action:** Monitor for any further deterioration and replace as required

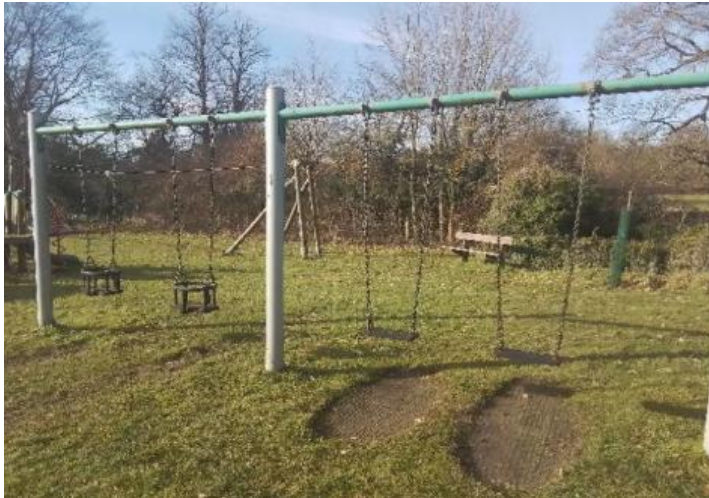
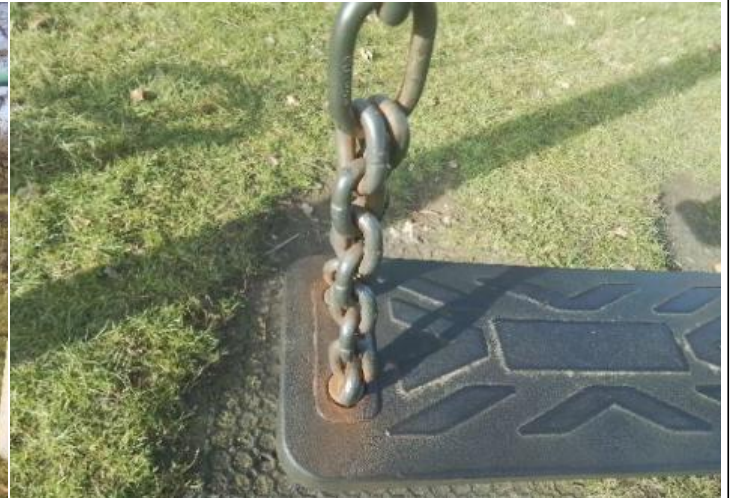
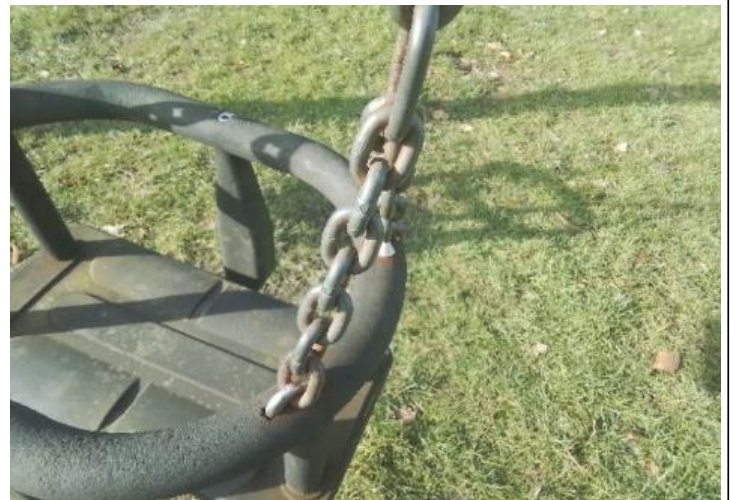
There is some notable evidence of chain wear - Monitor for any further deterioration and replace when 40% worn

**Finding:** There is some notable evidence of chain wear

**Action:** Monitor for any further deterioration and replace when 40% worn

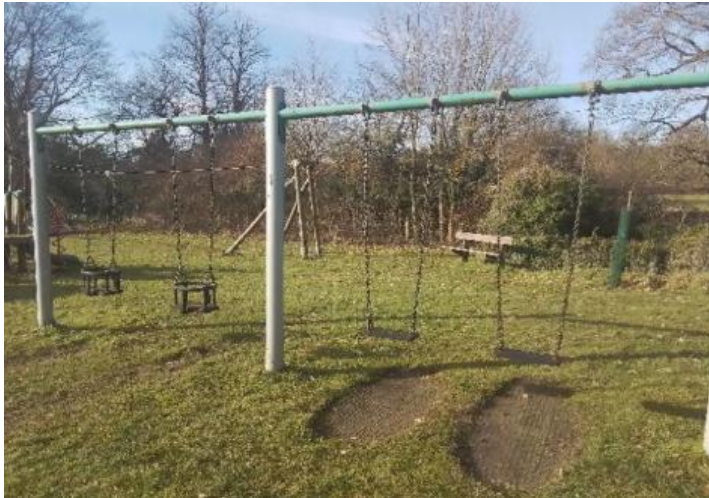
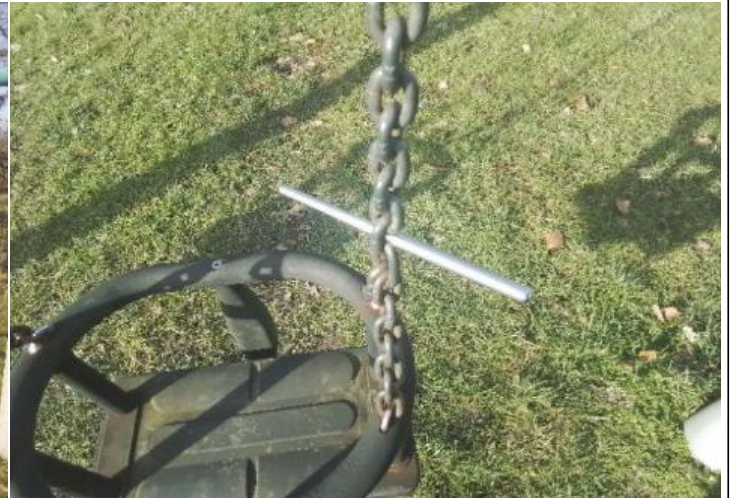
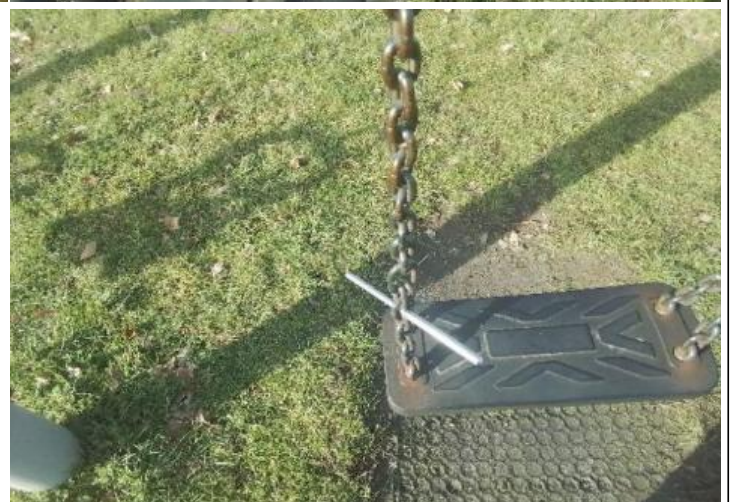
The chain openings are in excess of 8.6mm and do not meet the recommendations of BS EN 1176 Part 1 - Monitor - No remedial work recommended

**Finding:** The chain openings are in excess of 8.6mm and do not meet the recommendations of BS EN 1176 Part 1

**Action:** Monitor - No remedial work recommended

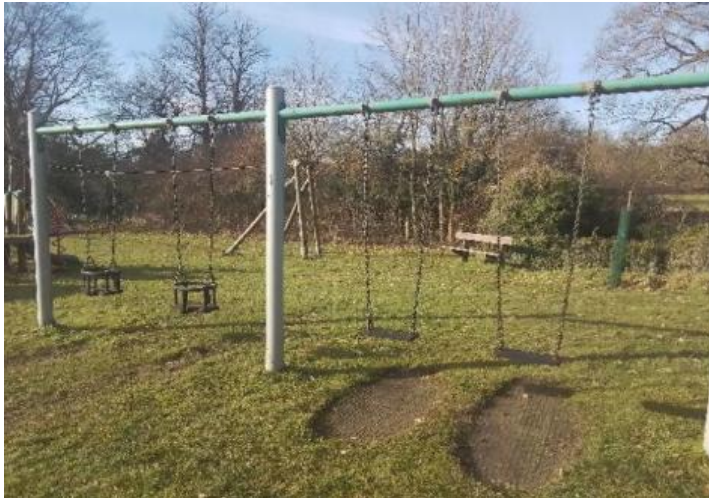
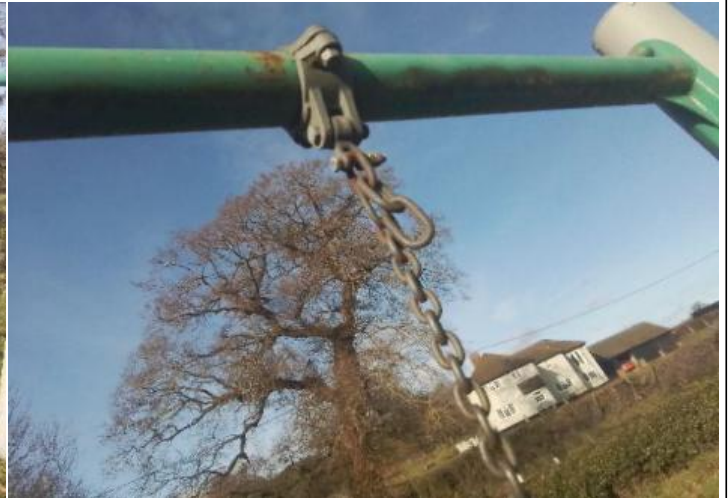
The chain links are worn in excess of 40% and require renewing - Replace worn chains

**Finding:** The chain links are worn in excess of 40% and require renewing

**Action:** Replace worn chains

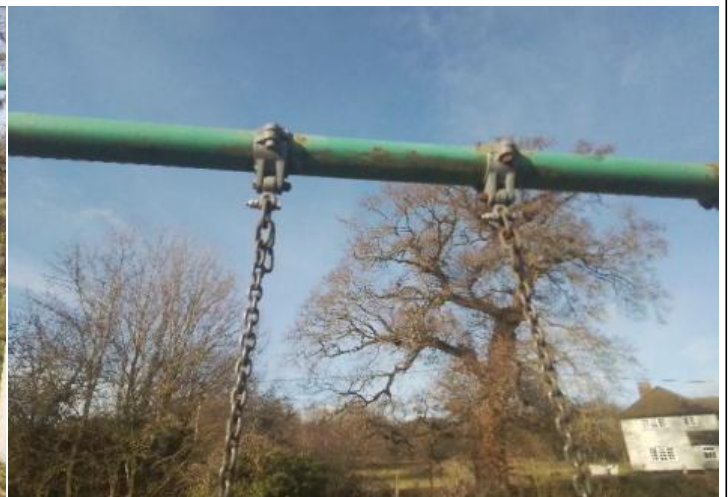
The bushes are worn or missing - Replace worn or missing bushes

**Finding:** The bushes are worn or missing

**Action:** Replace worn or missing bushes

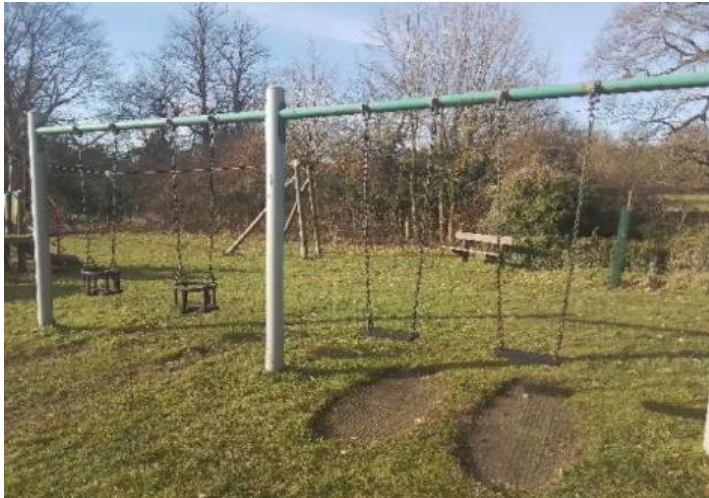
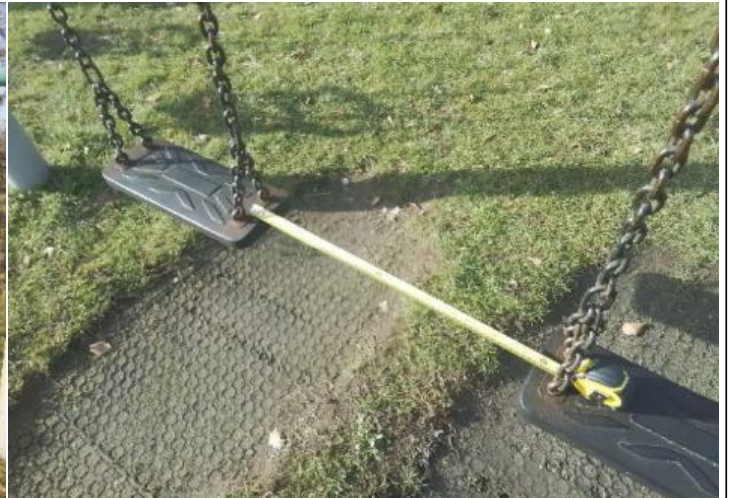
The seats are too close to each other as defined in BS EN 1176 Part 2; this is a low risk failure and no remedial action is required - Monitor - No remedial work recommended

**Finding:** The seats are too close to each other as defined in BS EN 1176 Part 2; this is a low risk failure and no remedial action is required  
**Action:** Monitor - No remedial work recommended

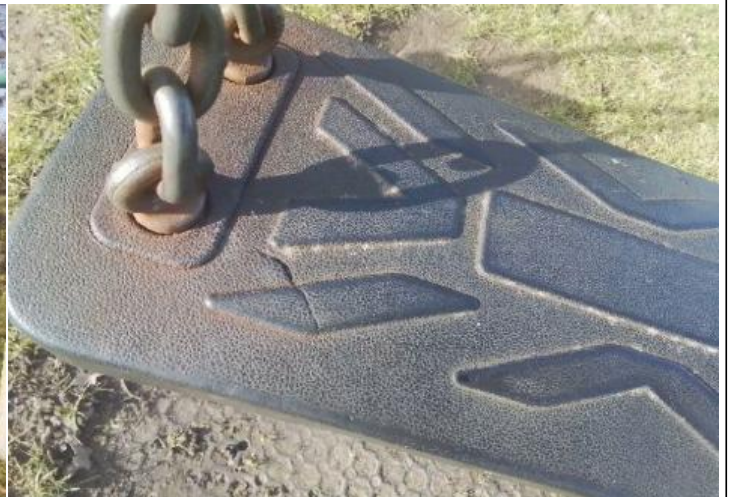
The seat has minor damage or wear - Monitor for any further deterioration and replace as required

**Finding:** The seat has minor damage or wear

**Action:** Monitor for any further deterioration and replace as required

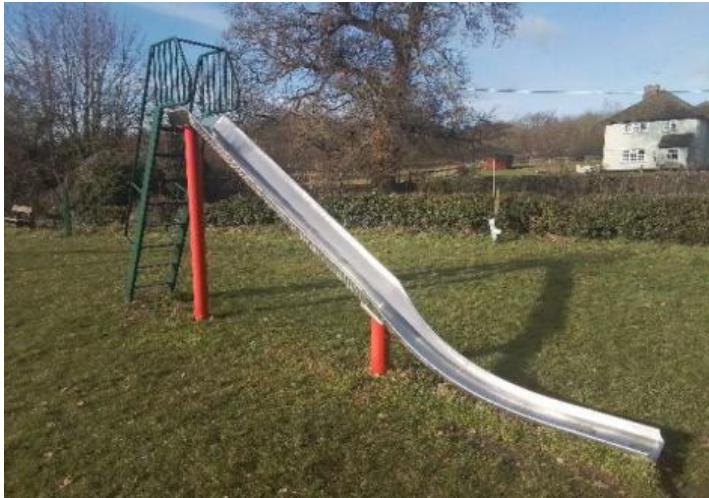
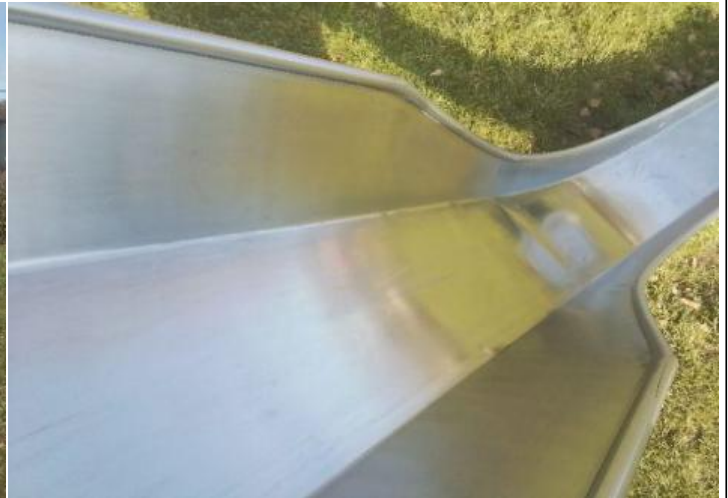
There are a number of dents in the slide surface - Monitor for any further deterioration and repair as required

**Finding:** There are a number of dents in the slide surface

**Action:** Monitor for any further deterioration and repair as required

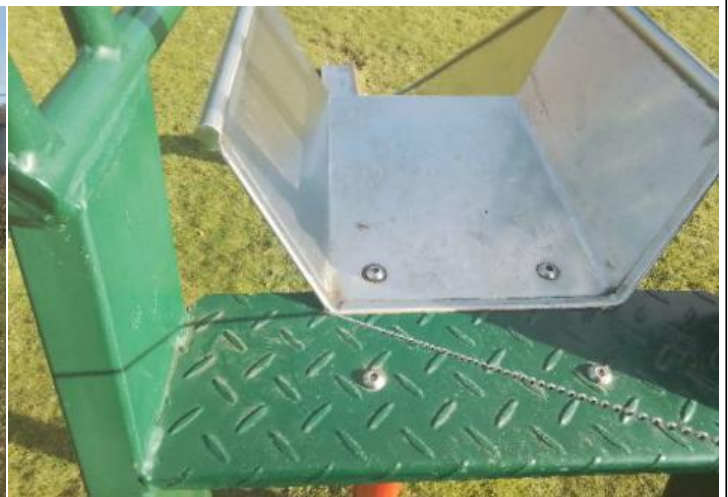
There is / are toggle entrapment/s present in contravention of the recommendations set out in BS EN 1176 Part 3 - Monitor - no remedial work recommended

**Finding:** There is / are toggle entrapment/s present in contravention of the recommendations set out in BS EN 1176 Part 3

**Action:** Monitor - no remedial work recommended

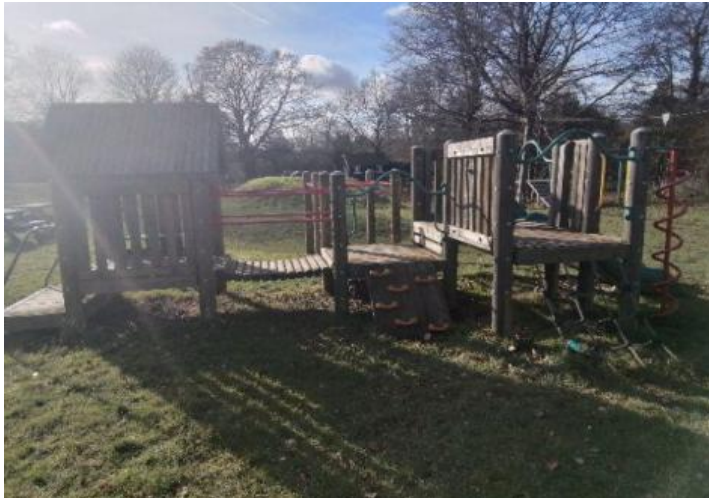
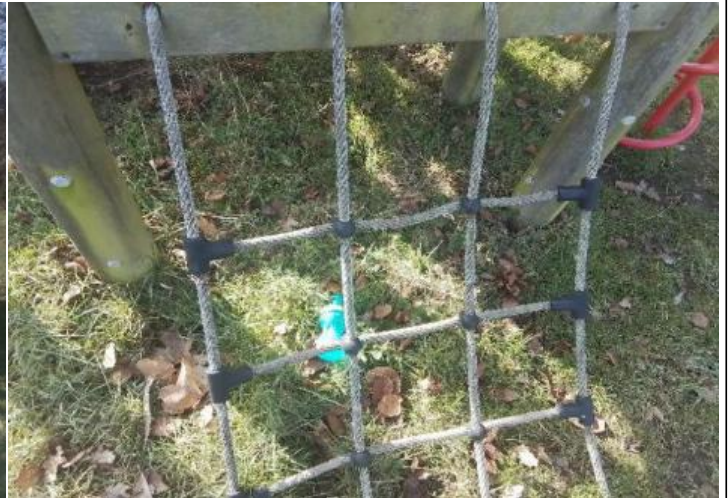
The ropes/nets are worn/damaged in places - Monitor for any further deterioration and repair or replace as required

**Finding:** The ropes/nets are worn/damaged in places

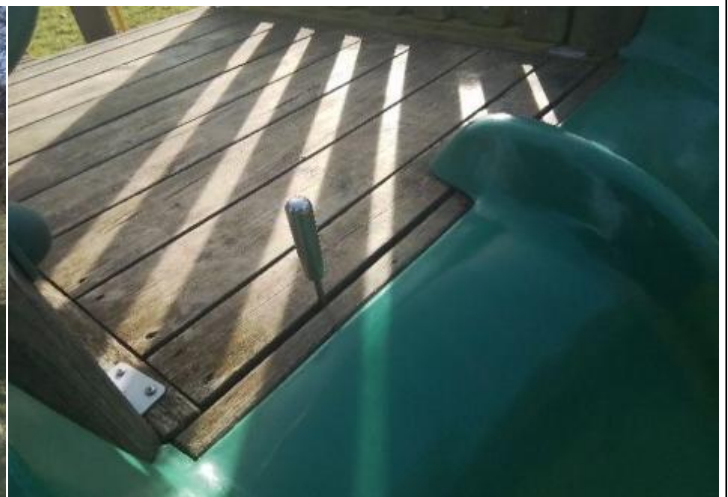
There is/are finger entrapment/s in the starting section of the slide and the item fails to meet the requirements of BS EN 1176 Part 1 4.2.7.6 Entrapment of fingers - Monitor - No remedial work recommended

**Finding:** There is/are finger entrapment/s in the starting section of the slide and the item fails to meet the requirements of BS EN 1176 Part 1 4.2.7.6 Entrapment of fingers

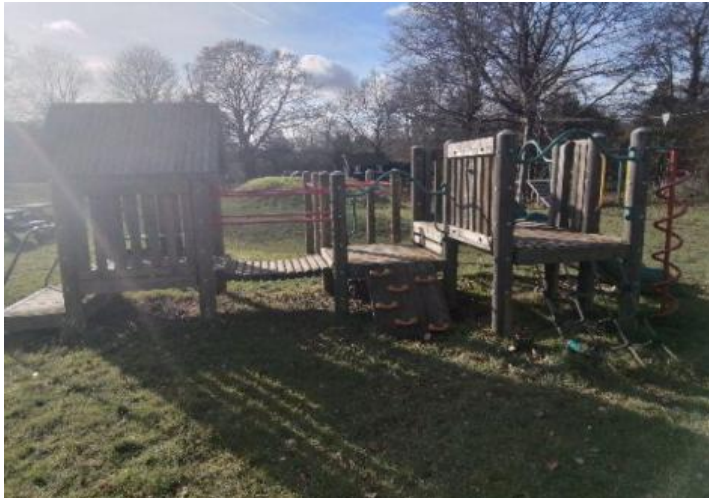
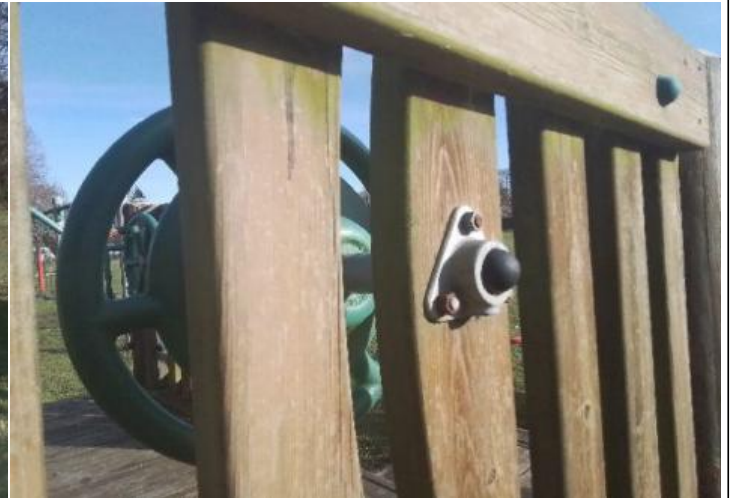
There is/are bolt cap covers missing or damaged on the item - Replace missing or damaged bolt cap covers

**Finding:** There is/are bolt cap covers missing or damaged on the item
