# the **play inspection** company

## Annual Inspection

Mid Suffolk District Council

Coddenham

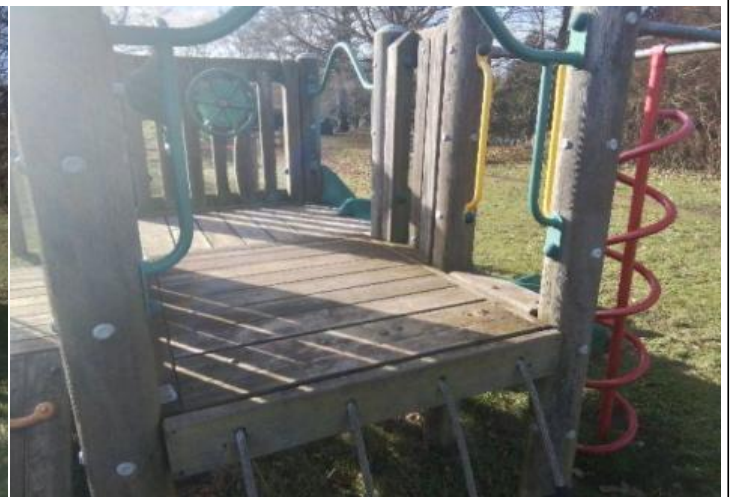
**Finding:** There is an opening in the barriers exceeding the width allowed (500mm) in BS EN 1176, this is a low risk failure and no remedial action is required

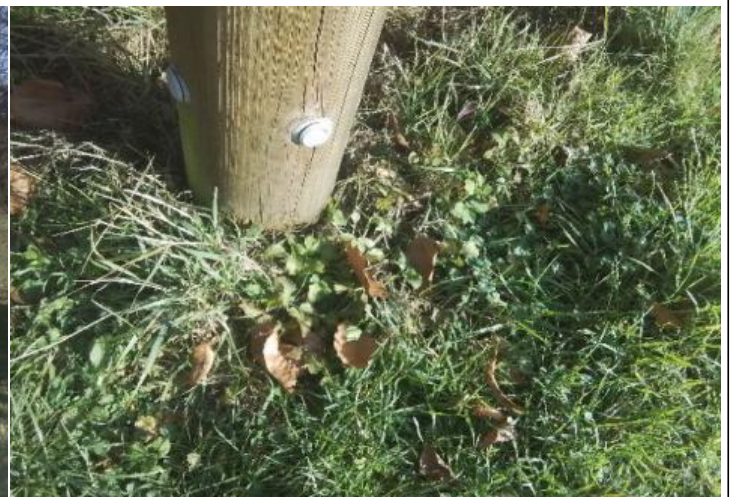
**Finding:** There is some strimmer / machinery damage apparent on the posts, this can penetrate the preservative applied to the timber and accelerate the rotting process. **Action:** Monitor for any deterioration (rot) and replace as required

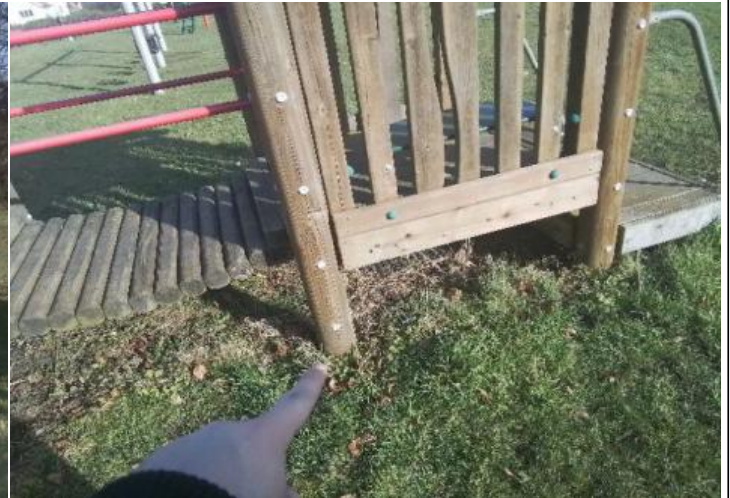
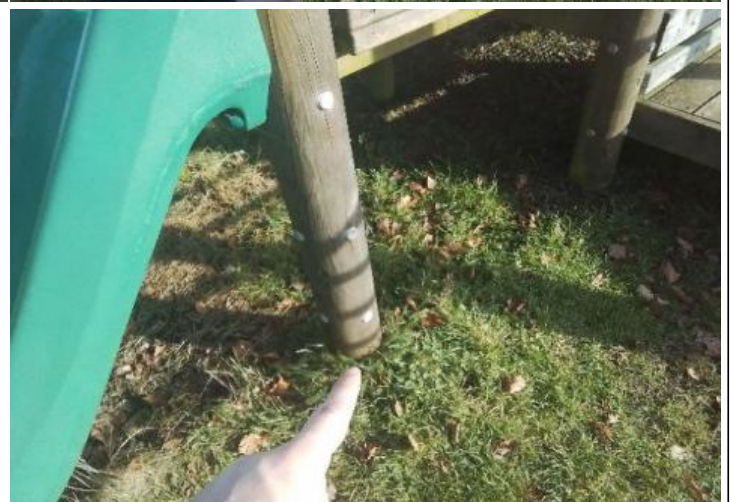
There are areas or parts of the timber on the structure that have rotted - Replace all affected timbers

**Finding:** There are areas or parts of the timber on the structure that have rotted

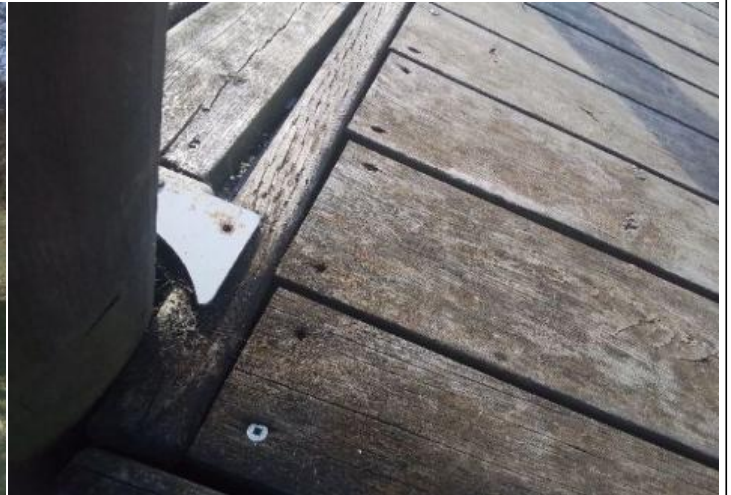
**Finding:** There is or are fixings missing on the item

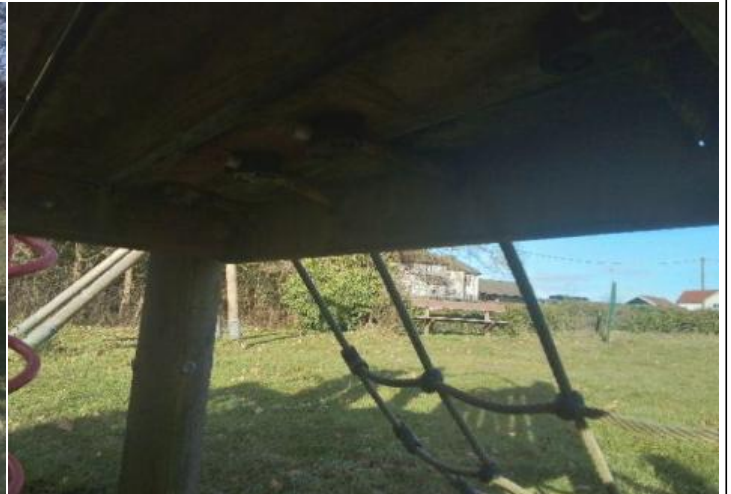
**Finding:** The end ferrule is missing from one rope on the cargo net

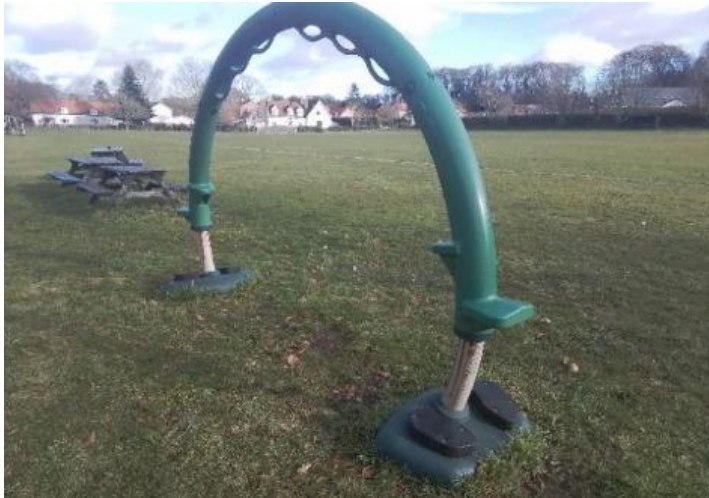
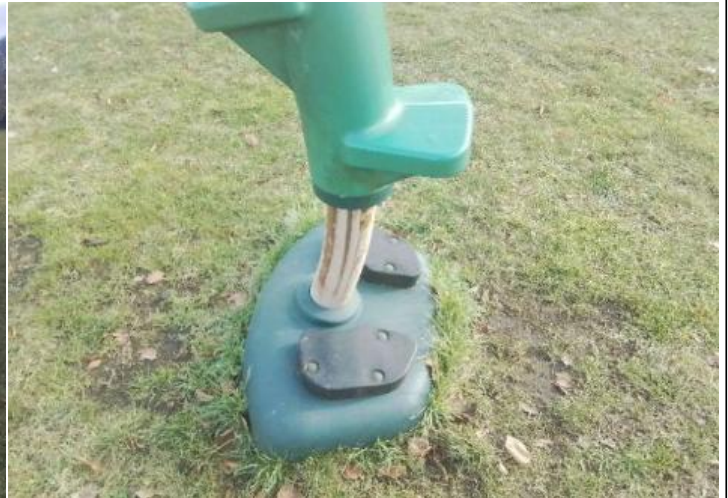
**Finding:** The paintwork on this item has been damaged or worn exposing the metal underneath which is rusting

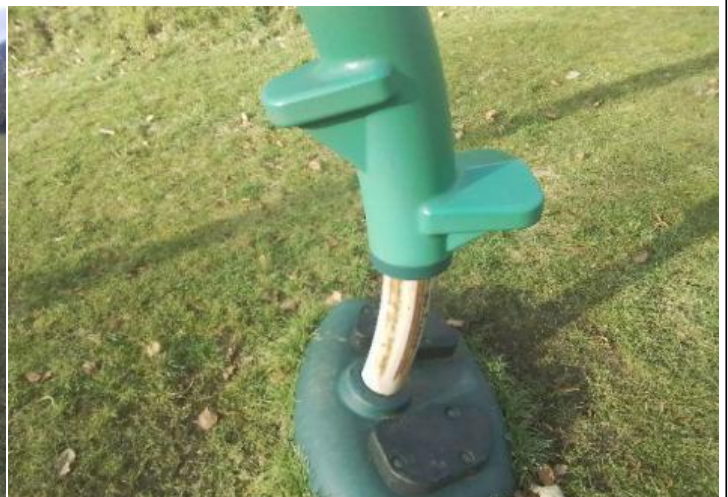
**Finding:** The buffers are wearing

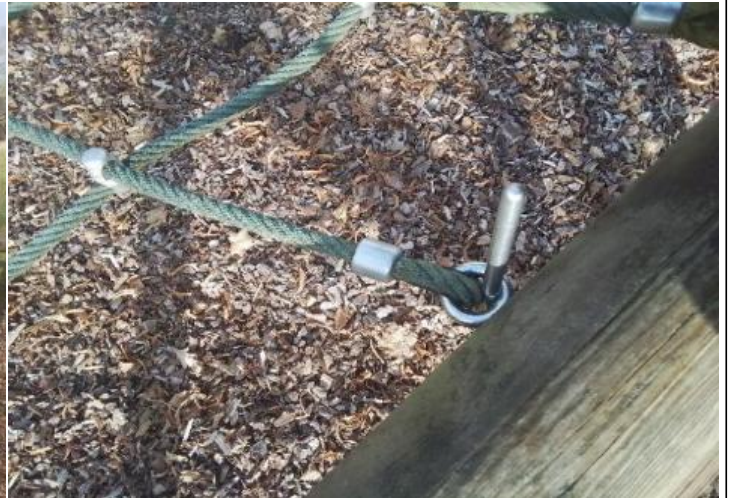
**Finding:** The connecting links are in excess of 8.6mm and less than 12mm and fail the requirements of BS EN 1176 Part 1; clause 4.2.13, Chains

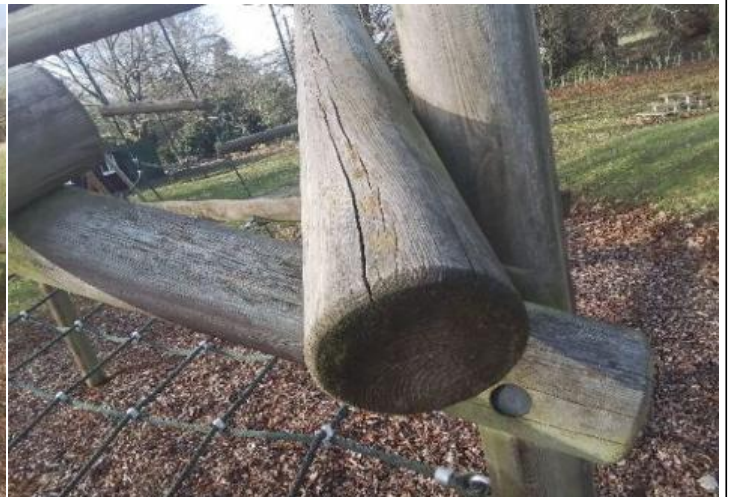
**Finding:** The timber has a number of splits/shakes or air cracks and this may affect the stability or allow water ingress which will accelerate the rotting process

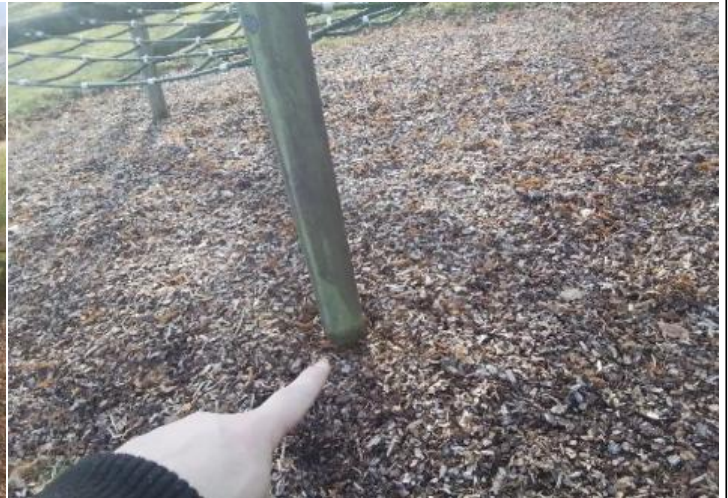
**Finding:** There is some evidence of rot in the timber

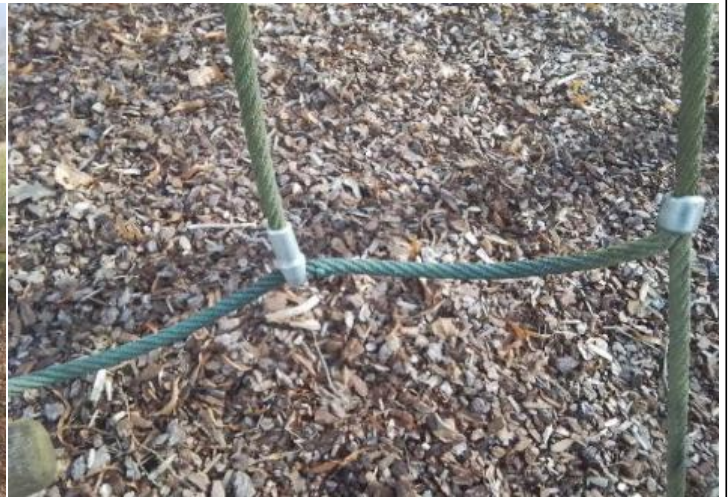
**Finding:** The ropes/nets are worn/damaged in places

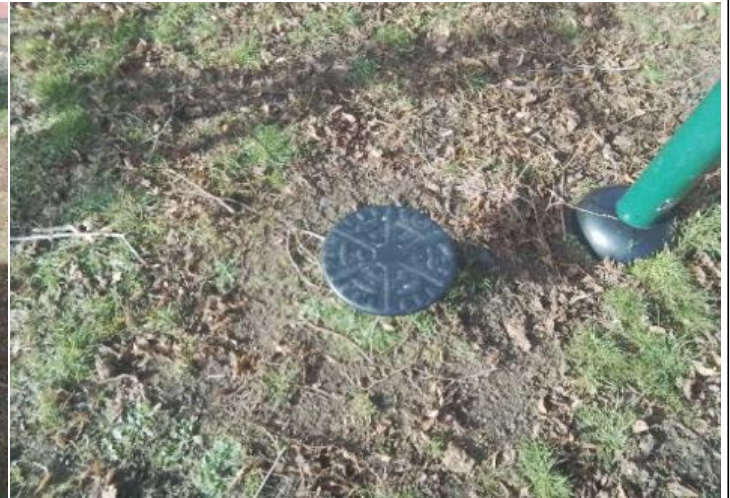
**Finding:** The deflection of the rotating user station exceeds the maximum 105 degrees required by BS EN 16630  
**Action:** Monitor - No remedial work recommended

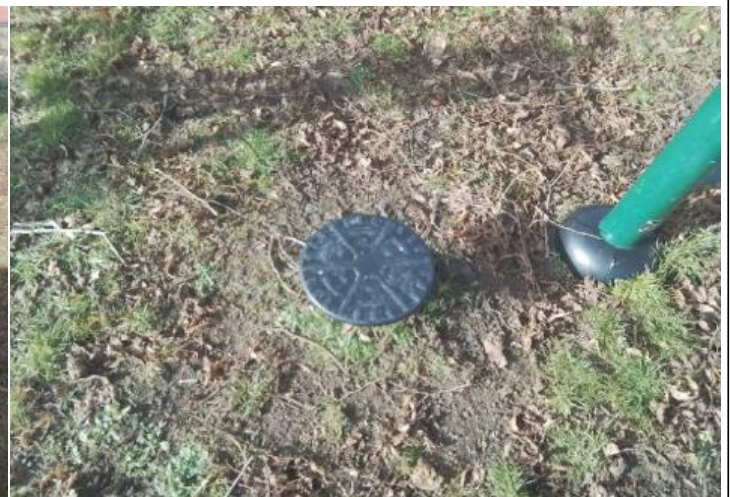
**Finding:** The rotating user station is not appropriately marked with a guideline of user direction and/or the original position as required by BS EN 16630  
**Action:** Monitor - No remedial work recommended

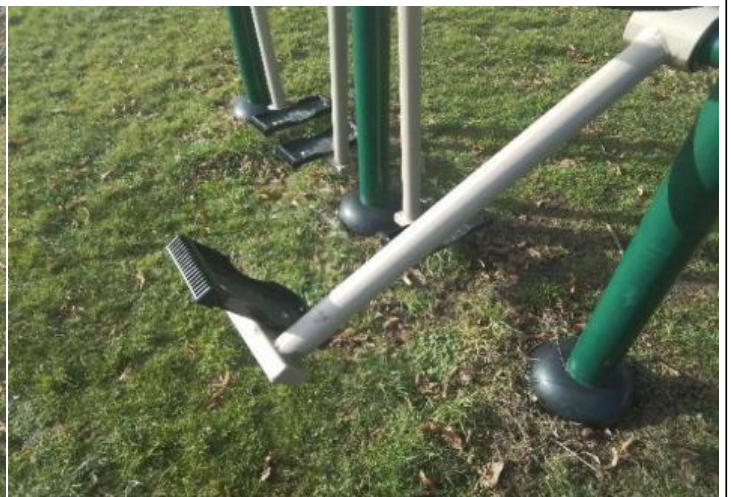
**Finding:** The swinging movement of the item exceeds the maximum 55 degrees from the vertical required by BS EN 16630

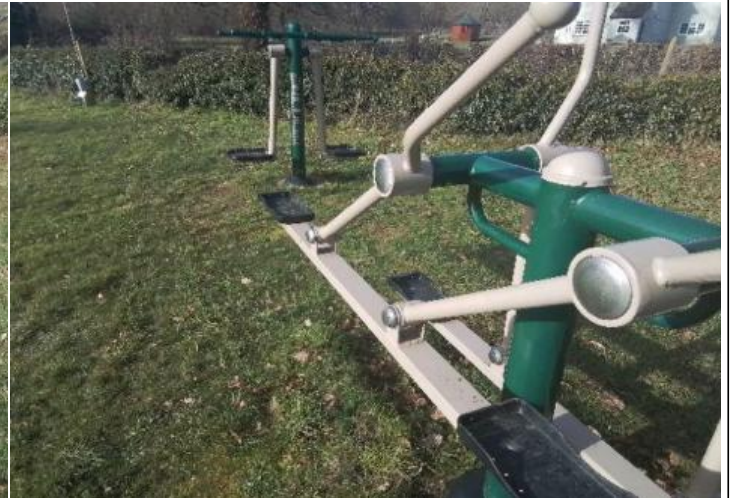
**Item:** Outdoor Fitness Equipment - Cross Trainer **Risk Level:** L - Low Risk  
**Manufacturer:** Fresh Air Fitness **Surface:** Grass Matrix Tiles

**Finding:** The swinging movement of the item exceeds the maximum 55 degrees from the vertical required by BS EN 16630

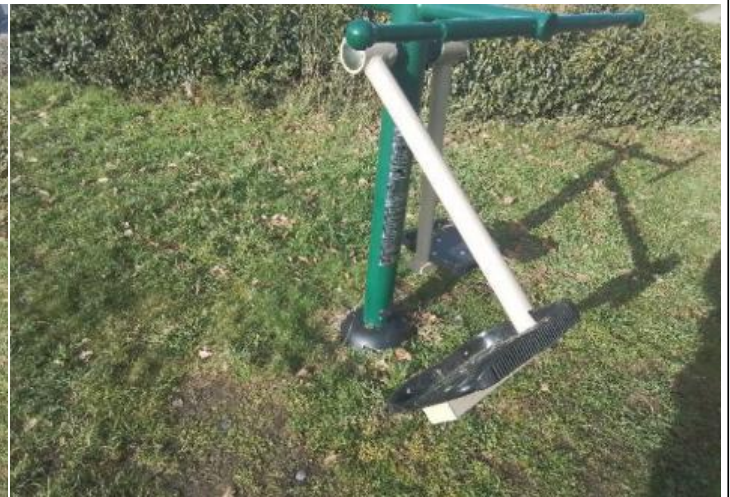
**Item:** Outdoor Fitness Equipment - Air Skier **Risk Level:** L - Low Risk  
**Manufacturer:** Fresh Air Fitness **Surface:** Grass Matrix Tiles

**Finding:** The swinging movement of the item exceeds the maximum 55 degrees from the vertical required by BS EN 16630
