# the **play inspection** company

## Annual Inspection

Mid Suffolk District Council

Coddenham

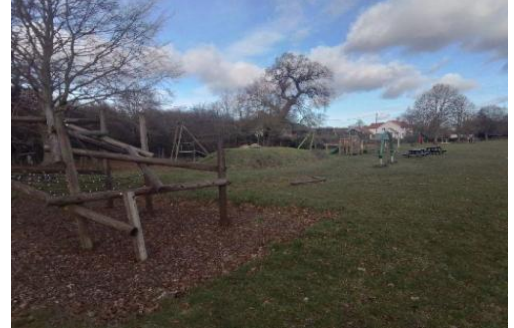
**Item:** Site General  
**Manufacturer:** Owner/Operator  
**Surface Type:** N/A  
**Item Quantity:** 1  
**Equipment Compliance:** N/A  
**Surface Area Compliance:** N/A

There is a redundant post in the area - Remove from play area

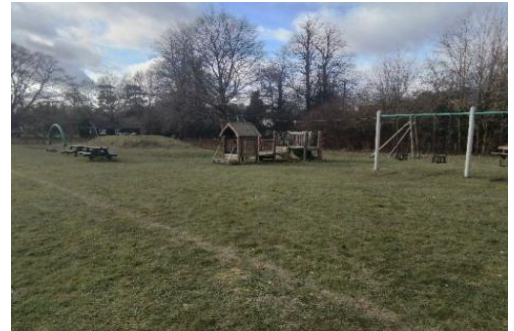
**Item:** Sign  
**Manufacturer:** Owner/Operator  
**Surface Type:** N/A  
**Item Quantity:** 1  
**Equipment Compliance:** N/A  
**Surface Area Compliance:** N/A

It is recommended that signage, with information including the site address, contact information for maintenance issues and emergency contact details are provided for the facility - Provide in accordance with the recommendations

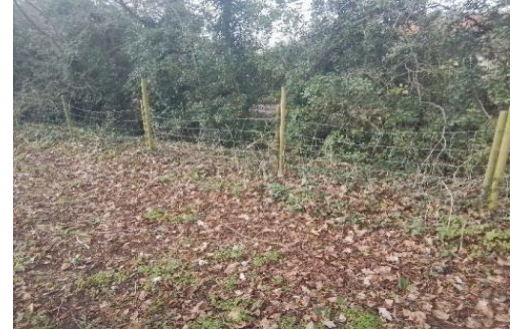
**Item:** Fence - Timber & Mesh Infill  
**Manufacturer:** Not Identified  
**Surface Type:** Grass  
**Item Quantity:** 1  
**Equipment Compliance:** N/A  
**Surface Area Compliance:** N/A

There is some damage to the fence sections - Monitor for any further deterioration and repair as required

There are a number of loose posts around the fence - Reset as required

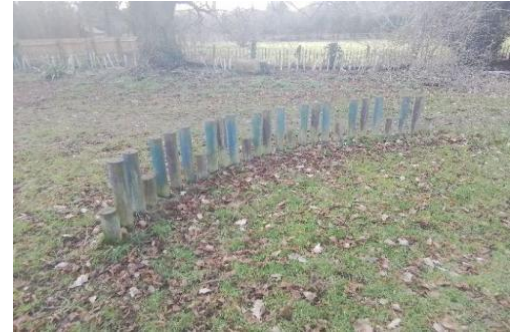
**Item:** Posts  
**Manufacturer:** Not Identified  
**Surface Type:** Grass  
**Item Quantity:** 1  
**Equipment Compliance:** N/A  
**Surface Area Compliance:** N/A

There are areas or parts of the timber on the structure that have rotted - Replace all affected timbers

The item is slightly loose in its foundations - Monitor for any further deterioration and repair as required

There is some strimmer / machinery damage apparent on the posts, this can penetrate the preservative applied to the timber and accelerate the rotting process - Monitor for any deterioration (rot) and replace as required

The timber has a number of splits/shakes or air cracks and this may affect the stability or allow water ingress which will accelerate the rotting process - Monitor to ensure the splits do not cross through fixing points of the structure and/or cause any instability

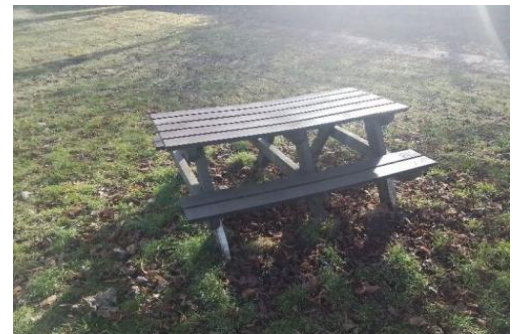
**Item:** Picnic Table  
**Manufacturer:** Not Identified  
**Surface Type:** Grass  
**Item Quantity:** 2  
**Equipment Compliance:** N/A  
**Surface Area Compliance:** N/A

The paintwork on this item has been damaged or worn exposing the metal underneath which is rusting - Treat any rusting components and repaint

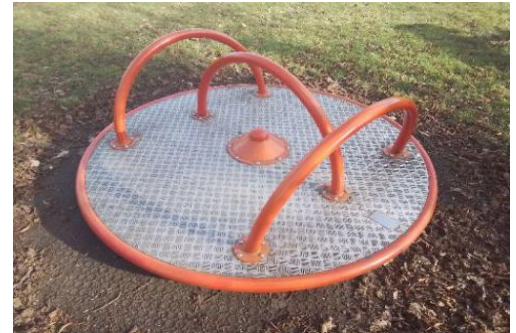
**Item:** Roundabout  
**Manufacturer:** Monster Play Systems  
**Surface Type:** Grass Matrix Tiles  
**Item Quantity:** 1  
**Equipment Compliance:** Yes  
**Surface Area Compliance:** No

The surfacing dimensions are short and do not meet with the requirements of the current applicable standard -  
 Monitor - no remedial action recommended

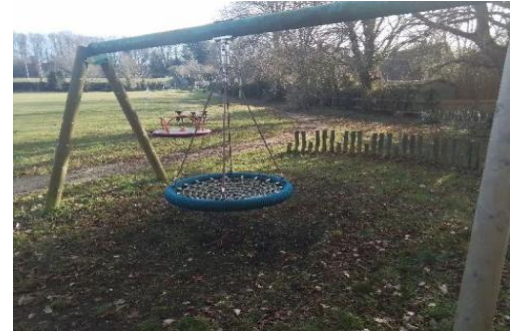
**Item:** Basket Swing - Type 1  
**Manufacturer:** Monster Play Systems  
**Surface Type:** Grass Matrix Tiles  
**Item Quantity:** 1  
**Equipment Compliance:** No  
**Surface Area Compliance:** Yes

The surface has subsided in some areas - Monitor for any further deterioration and repair as required

The ropes/nets are worn/damaged in places - Monitor for any further deterioration and repair or replace as required

The connecting links are in excess of 8.6mm and less than 12mm and fail the requirements of BS EN 1176 Part 1; clause 4.2.13, Chains - Monitor use and replace with compliant links at the next maintenance cycle

A number of fixing(s) have worked loose - Secure all loose fixings

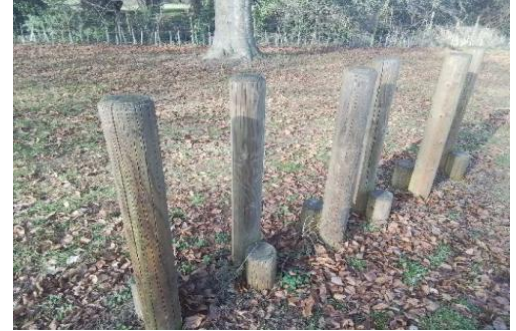
**Item:** Stilts  
**Manufacturer:** Monster Play Systems  
**Surface Type:** Grass  
**Item Quantity:** 1  
**Equipment Compliance:** Yes  
**Surface Area Compliance:** Yes

There is some strimmer / machinery damage apparent on the posts, this can penetrate the preservative applied to the timber and accelerate the rotting process - Monitor for any deterioration (rot) and replace as required

The timber has a number of splits/shakes or air cracks and this may affect the stability or allow water ingress which will accelerate the rotting process - Monitor to ensure the splits do not cross through fixing points of the structure and/or cause any instability

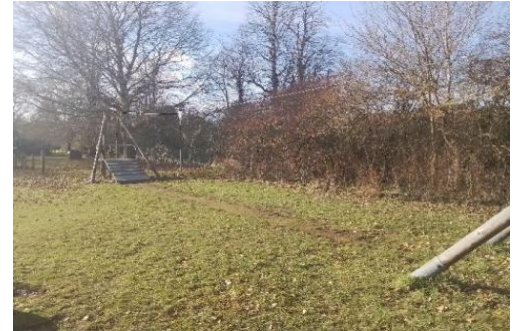
**Item:** Cable Runway  
**Manufacturer:** Monster Play Systems  
**Surface Type:** Grass Matrix Tiles  
**Item Quantity:** 1  
**Equipment Compliance:** Yes  
**Surface Area Compliance:** Yes

We have completed a visual inspection of the suspension links, cable and fixing points from ground level, however it is not possible to fully inspect these areas without either hiring equipment to gain access or removing the cable and suspension and inspecting at ground level. We recommend that the main cable and fixing security is thoroughly inspected at least in accordance with the manufacturers recommendations to check for wear, damage, security or internal rusting; this will help to ensure the continued safe use of the equipment - Inspect in accordance with the manufacturers recommendations

The timber has a number of splits/shakes or air cracks and this may affect the stability or allow water ingress which will accelerate the rotting process - Monitor to ensure the splits do not cross through fixing points of the structure and/or cause any instability

There is/are bolt cap covers missing or damaged on the item - Replace missing or damaged bolt cap covers

The grass mats are silted up and the soil is compacted; this may have an effect on the impact absorbing properties of the surface - Consider HIC testing impact absorbing properties to ensure the correct surface qualities are maintained for the equipment and replace as required

The seat connection cannot be inspected without dismantling the seat - Dismantle the seat to inspect the seat connection for wear

The seat suspension cover has been damaged - Monitor for any further deterioration and replace as required

The cableway seat has been damaged - Monitor for any further deterioration and replace as required

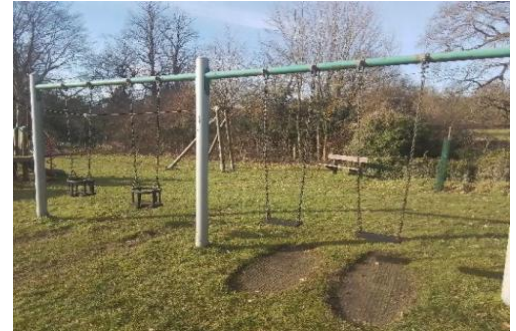
**Item:** 2 Bay (2 Flat, 2 Cradle)  
**Manufacturer:** Monster Play Systems  
**Surface Type:** Grass Matrix Tiles  
**Item Quantity:** 1  
**Equipment Compliance:** No  
**Surface Area Compliance:** Yes

There is some notable evidence of chain wear - Monitor for any further deterioration and replace when 40% worn

The chain openings are in excess of 8.6mm and do not meet the recommendations of BS EN 1176 Part 1 - Monitor - No remedial work recommended

The chain links are worn in excess of 40% and require renewing - Replace worn chains

The bushes are worn or missing - Replace worn or missing bushes

The seats are too close to each other as defined in BS EN 1176 Part 2; this is a low risk failure and no remedial action is required - Monitor - No remedial work recommended

The seat has minor damage or wear - Monitor for any further deterioration and replace as required

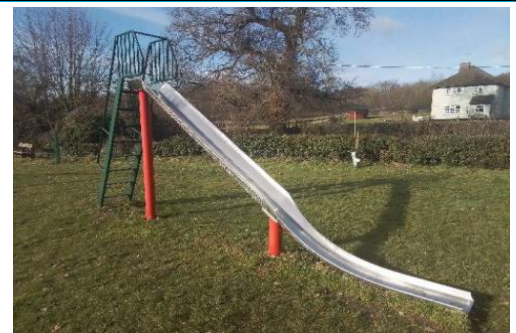
**Item:** Free Standing Slide  
**Manufacturer:** Wicksteed Playgrounds  
**Surface Type:** Grass Matrix Tiles  
**Item Quantity:** 1  
**Equipment Compliance:** No  
**Surface Area Compliance:** Yes

There are a number of dents in the slide surface - Monitor for any further deterioration and repair as required

There is / are toggle entrapment/s present in contravention of the recommendations set out in BS EN 1176 Part 3 - Monitor - no remedial work recommended

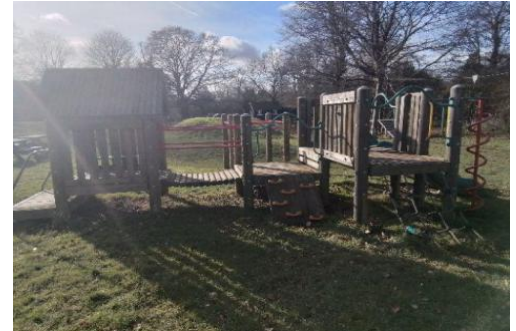
**Item:** Multi Play (Toddler)  
**Manufacturer:** Monster Play Systems  
**Surface Type:** Grass Matrix Tiles  
**Item Quantity:** 1  
**Equipment Compliance:** No  
**Surface Area Compliance:** Yes

The ropes/nets are worn/damaged in places - Monitor for any further deterioration and repair or replace as required

There is/are finger entrapment/s in the starting section of the slide and the item fails to meet the requirements of BS EN 1176 Part 1 4.2.7.6 Entrapment of fingers - Monitor - No remedial work recommended

There is/are bolt cap covers missing or damaged on the item - Replace missing or damaged bolt cap covers

There are areas or parts of the timber on the structure that have rotted - Replace all affected timbers

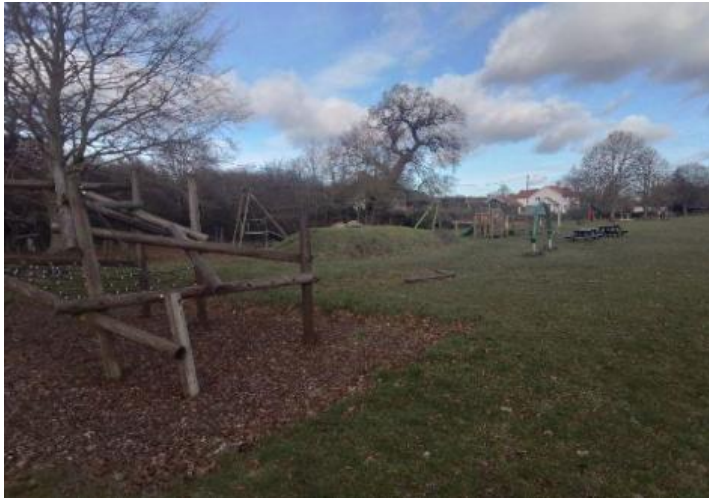
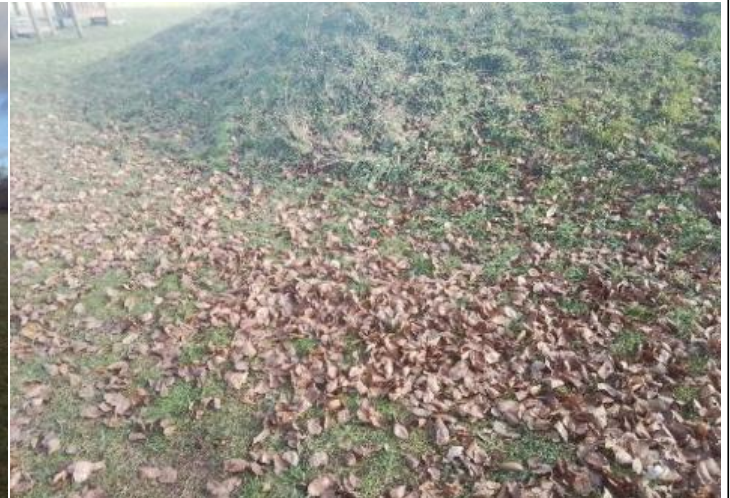
**Item:** Ancillary Items - Site General      **Risk Level:** L - Low Risk  
**Manufacturer:** Owner/Operator      **Surface:** N/A

**Finding:** There is some tree debris on the surfacing

**Action:** Remove and maintain

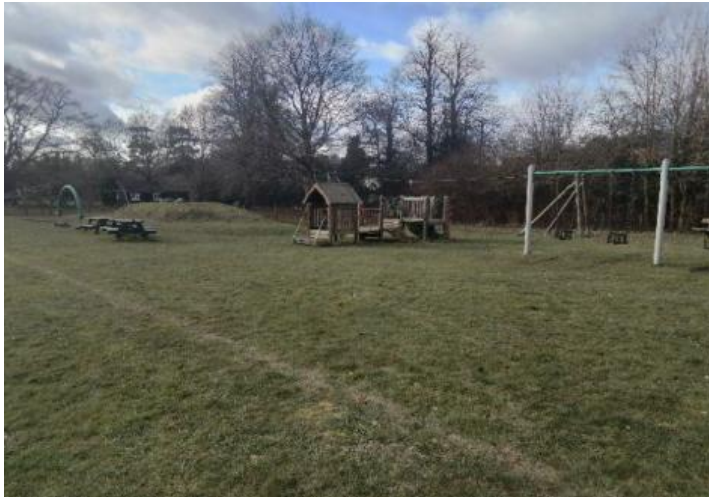
**Item:** Ancillary Items - Sign      **Risk Level:** V - Very Low Risk  
**Manufacturer:** Owner/Operator      **Surface:** N/A

**Finding:** It is recommended that signage, with information including the site address, contact information for maintenance issues and emergency contact details are provided for the facility

**Action:** Provide in accordance with the recommendations

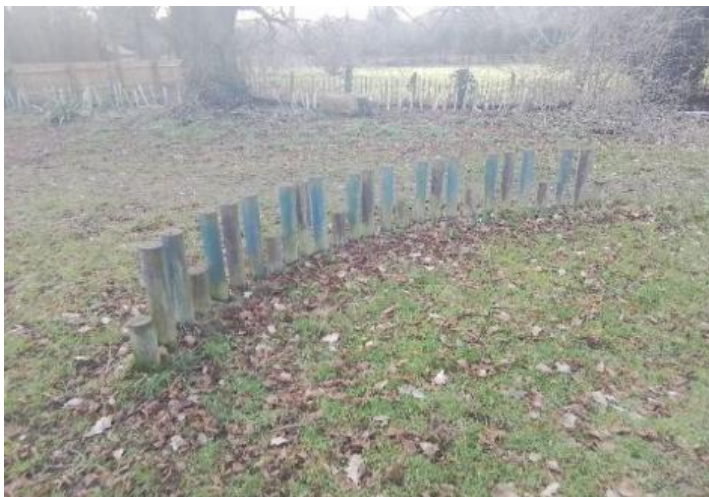
**Item:** Gates - Posts  
**Manufacturer:** Not Identified

**Finding:** There is some strimmer / machinery damage apparent on the posts, this can penetrate the preservative applied to the timber and accelerate the rotting process

**Action:** Monitor for any deterioration (rot) and replace as required

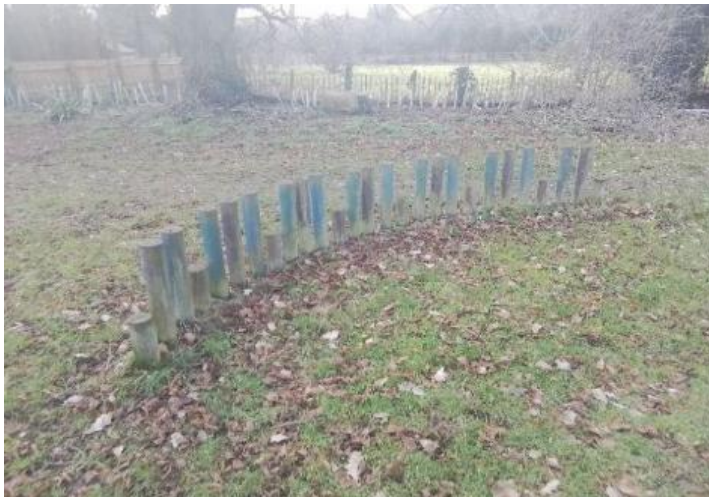
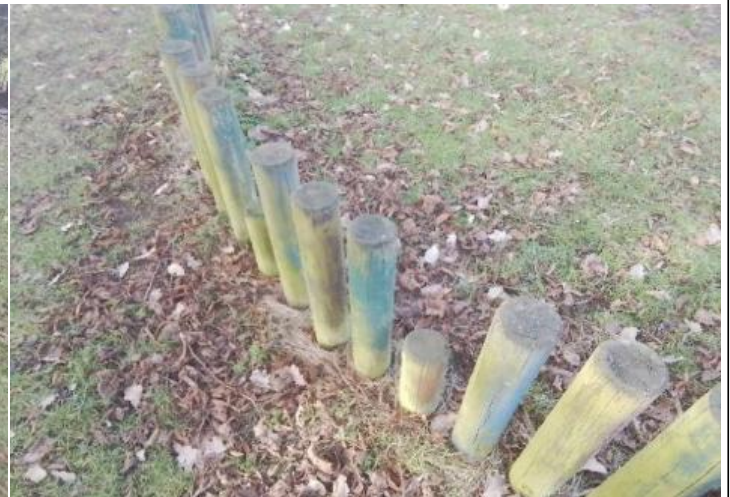
**Item:** Gates - Posts  
**Manufacturer:** Not Identified

**Finding:** There is algae or moss on the surface of the equipment  
**Action:** Clean and treat appropriately

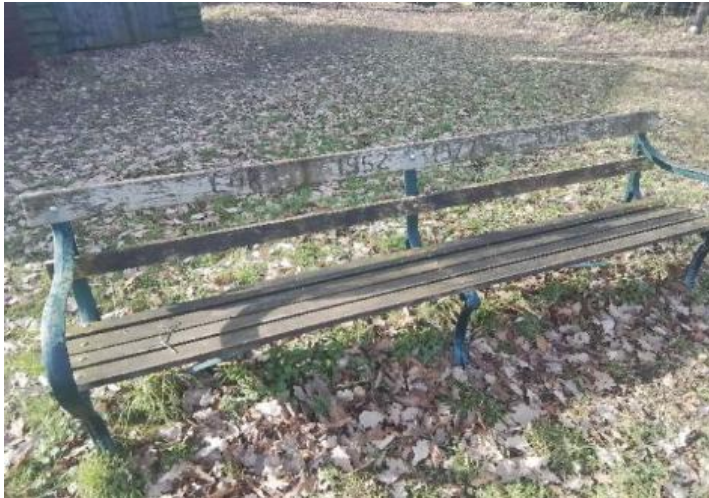
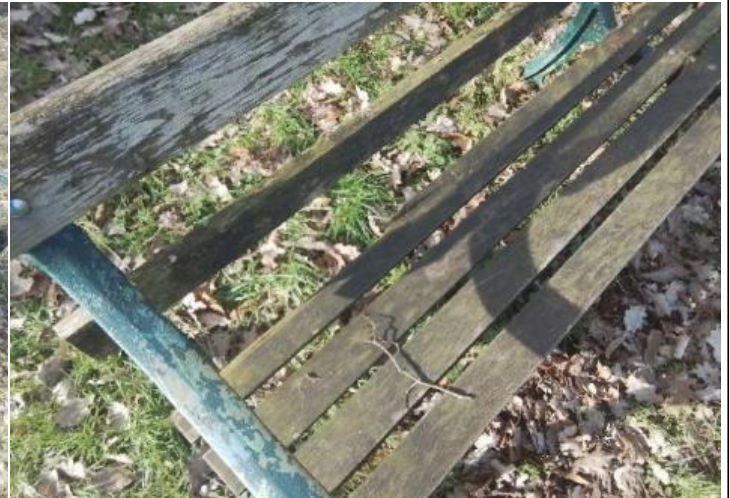
**Item:** Ancillary Items - Bench  
**Manufacturer:** Not Identified

**Finding:** Parts of the timber are rough or splintered

**Action:** Remove all rough or sharp edges

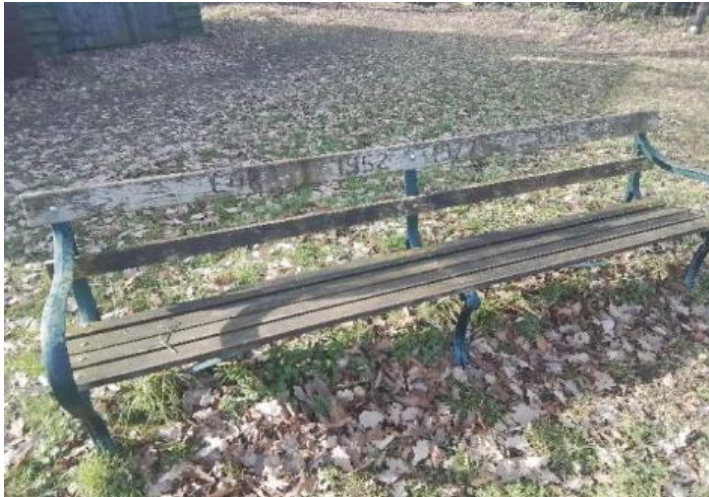
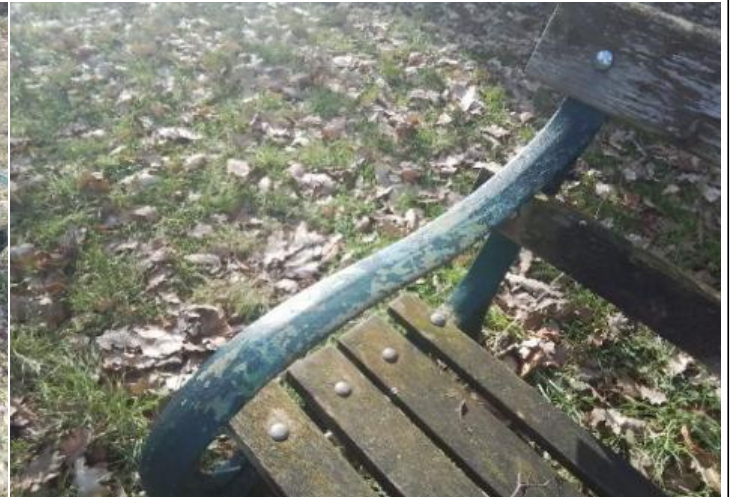
**Item:** Ancillary Items - Bench  
**Manufacturer:** Not Identified

**Finding:** The paint is flaking off the metalwork

**Action:** Rub down and re-paint

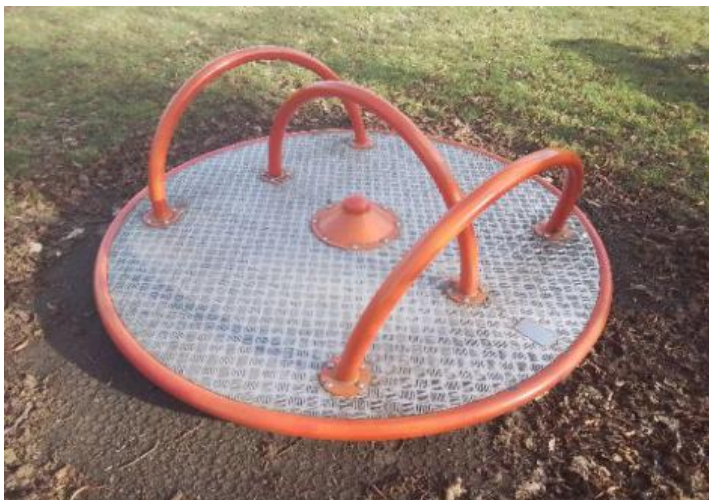
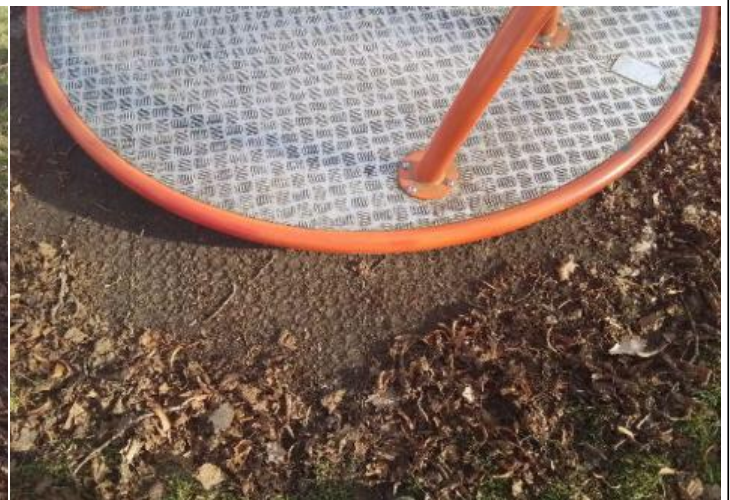
**Item:** Rotor Play - Roundabout  
**Manufacturer:** Monster Play Systems

**Finding:** The grass mats are silted up, the soil is compacted and the area will become very slippery when the soil is wet.

**Action:** Reinstate as required

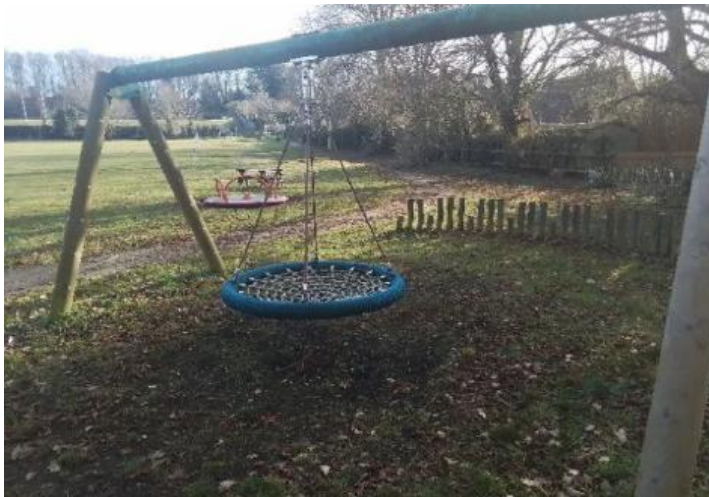
**Finding:** The surface has subsided in some areas

**Action:** Monitor for any further deterioration and repair as required

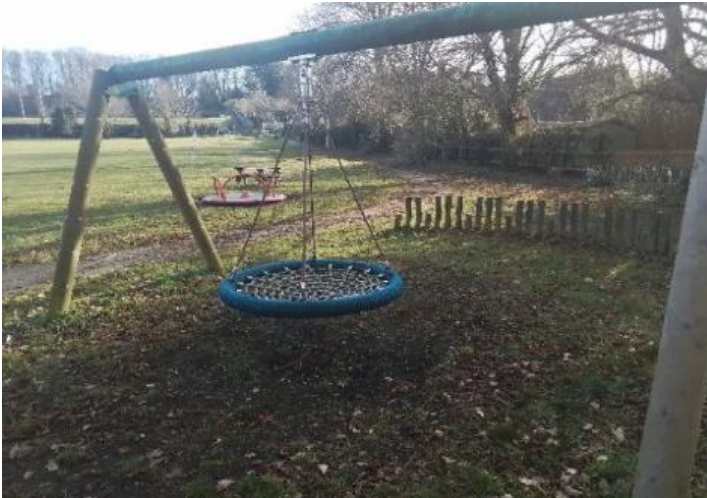
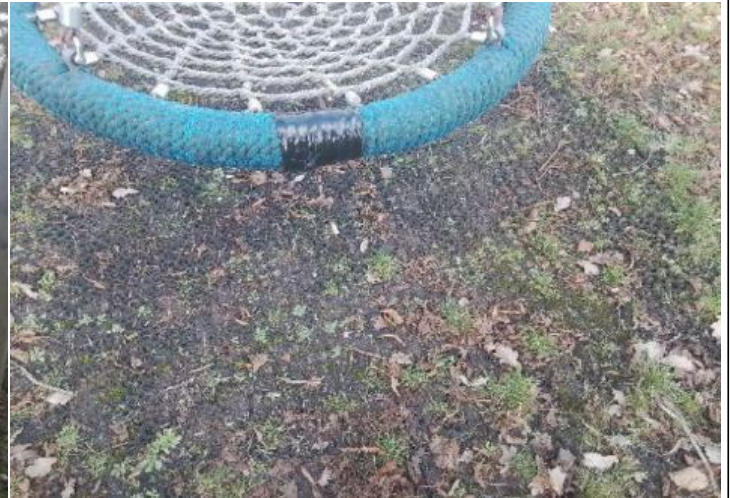
**Finding:** There are gaps opening between the grass mat tiles

**Action:** Provide additional ties or secure / reinstate surface tiles

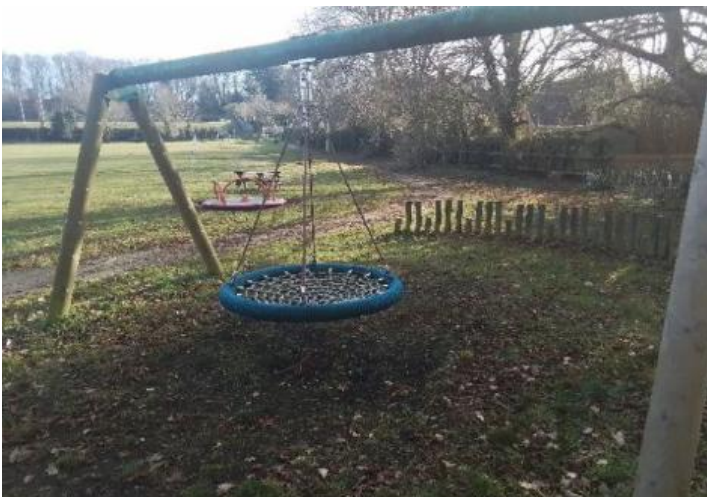
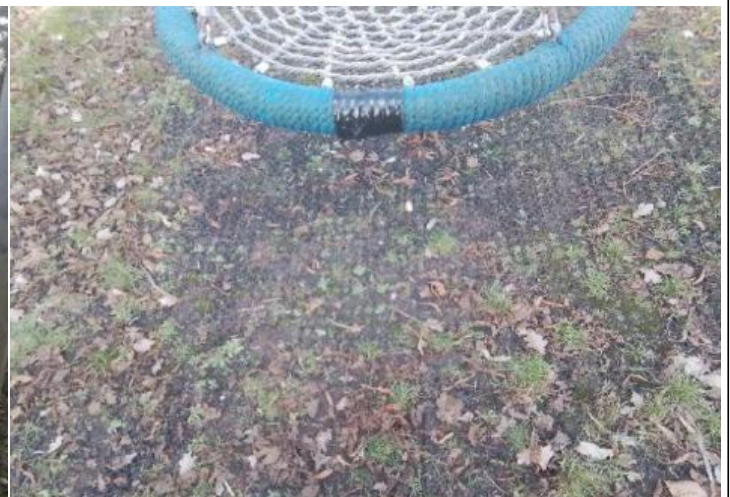
**Finding:** There is a lack of growth within the grass

**Action:** Encourage growth with grass seeds

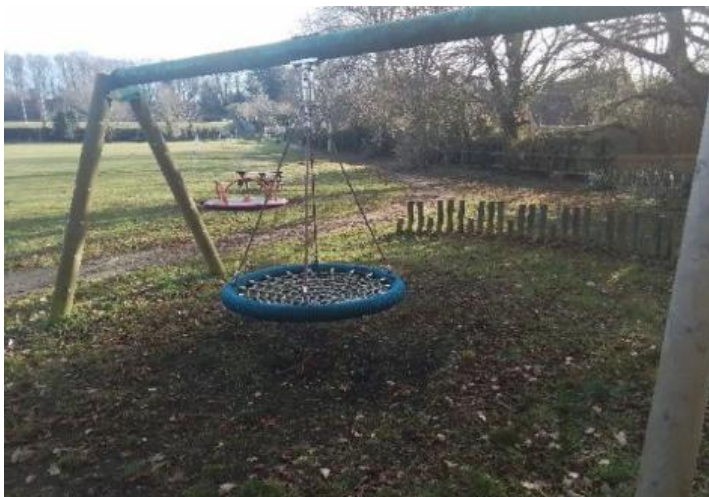
**Finding:** The connecting links are in excess of 8.6mm and less than 12mm and fail the requirements of BS EN 1176 Part 1; clause 4.2.13, Chains

**Action:** Monitor use and replace with compliant links at the next maintenance cycle

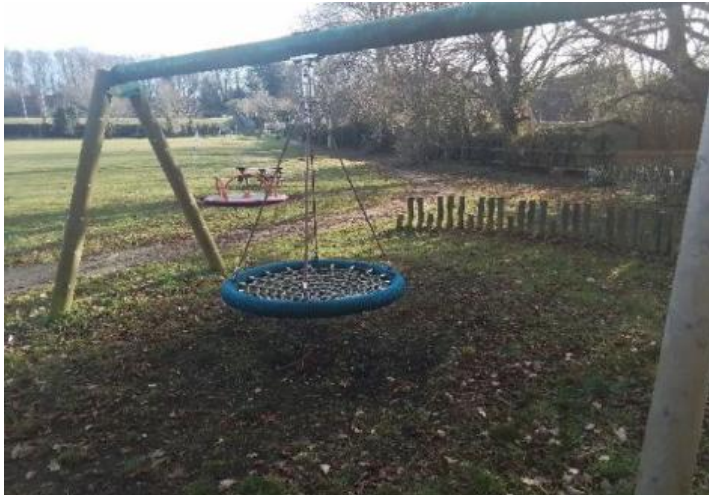
**Finding:** A number of fixing(s) have worked loose

**Action:** Secure all loose fixings

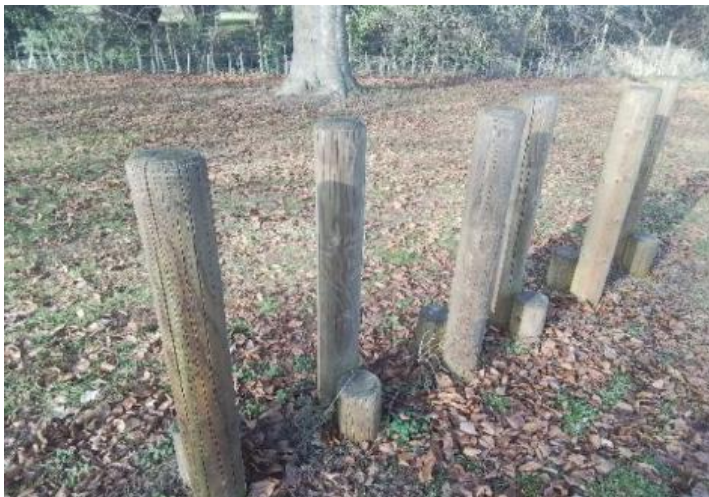
**Finding:** There is some strimmer / machinery damage apparent on the posts, this can penetrate the preservative applied to the timber and accelerate the rotting process

**Action:** Monitor for any deterioration (rot) and replace as required

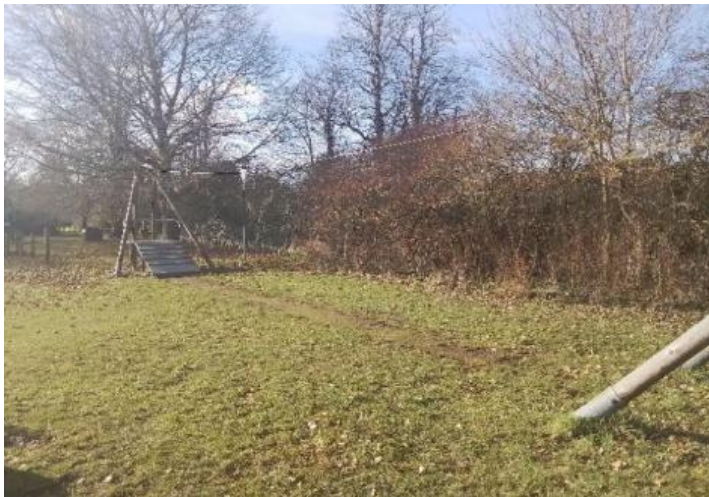
**Finding:** There is/are bolt cap covers missing or damaged on the item  
**Action:** Replace missing or damaged bolt cap covers

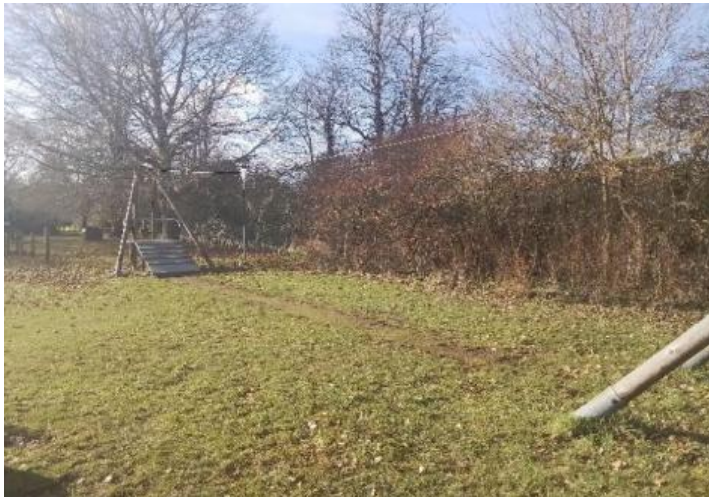
**Finding:** The cableway seat has been damaged

**Action:** Monitor for any further deterioration and replace as required

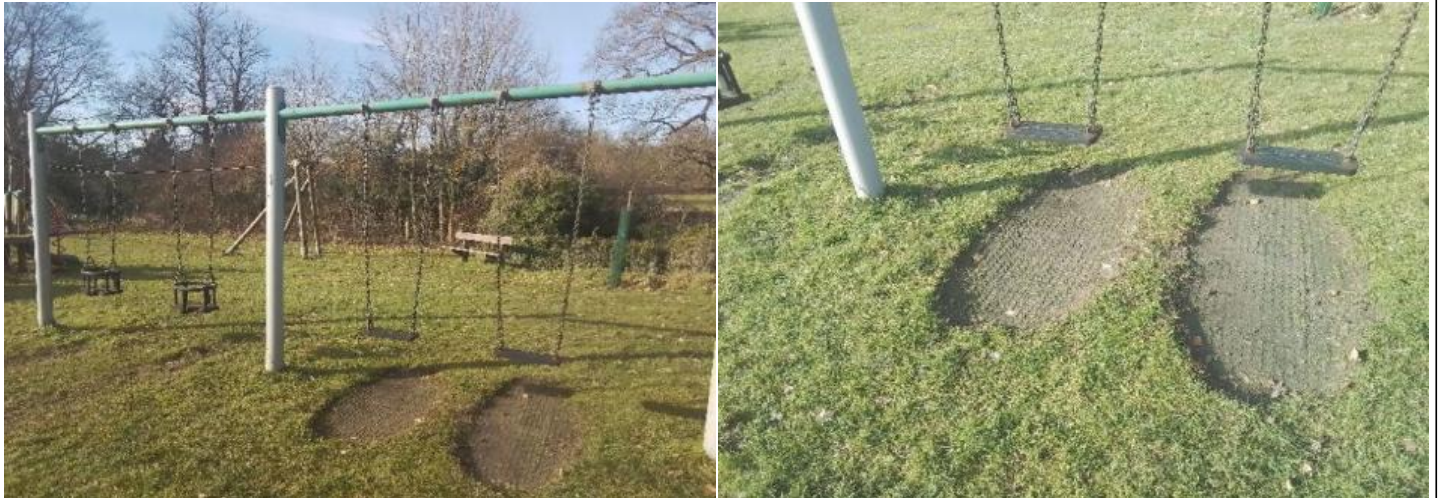
**Finding:** The grass mats are silted up, the soil is compacted and the area will become very slippery when the soil is wet. **Action:** Reinstate as required

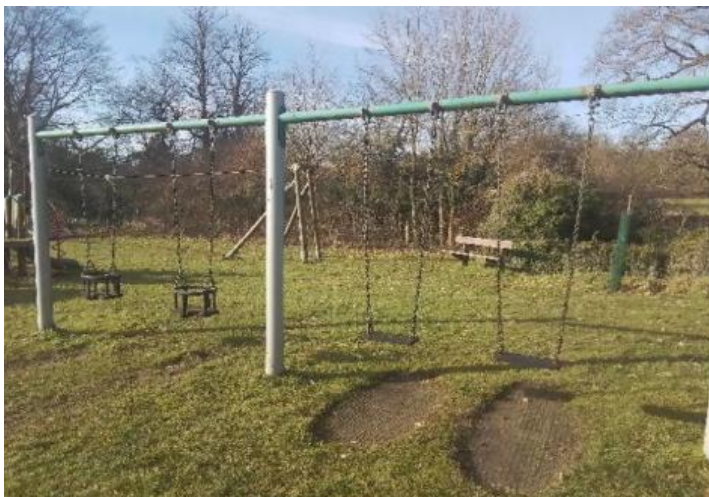
**Finding:** The bushes are worn or missing

**Action:** Replace worn or missing bushes

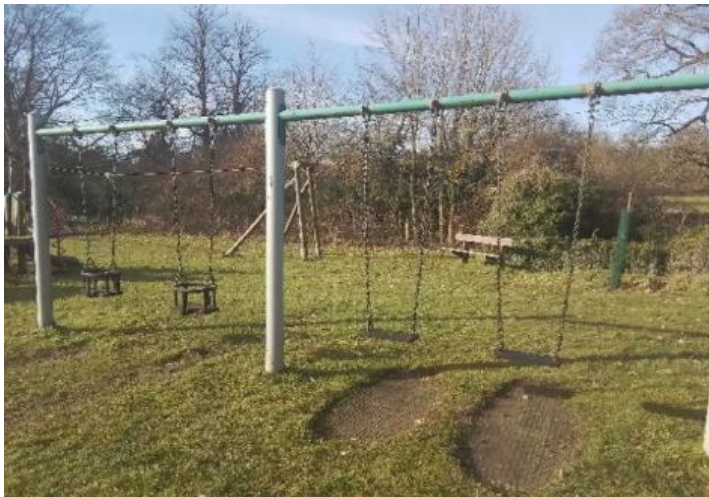
**Finding:** The seat has minor damage or wear

**Action:** Monitor for any further deterioration and replace as required

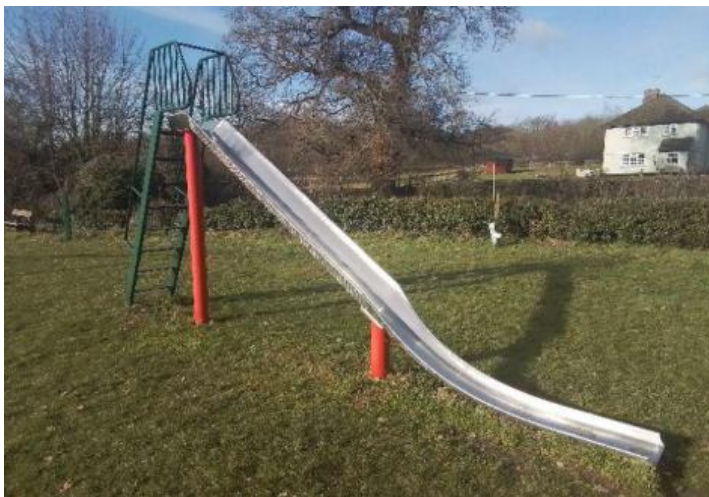
**Finding:** There is / are toggle entrapment/s present in contravention of the recommendations set out in BS EN 1176 Part 3

**Action:** Monitor - no remedial work recommended

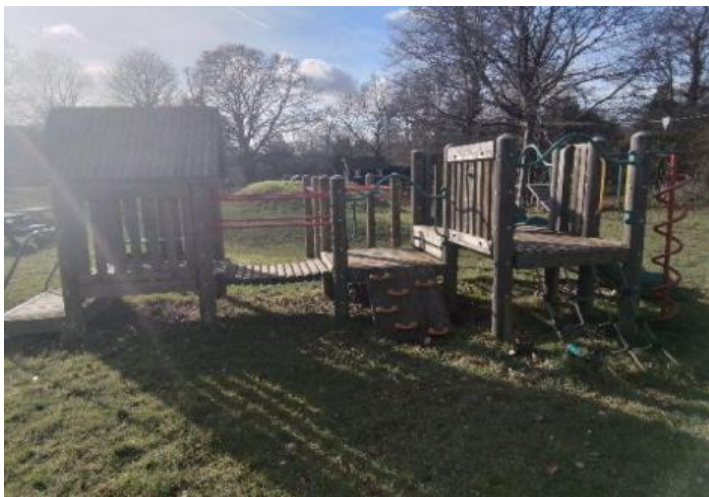
**Finding:** There is/are finger entrapment/s in the starting section of the slide and the item fails to meet the requirements of BS EN 1176 Part 1 4.2.7.6 Entrapment of fingers

**Action:** Monitor - No remedial work recommended

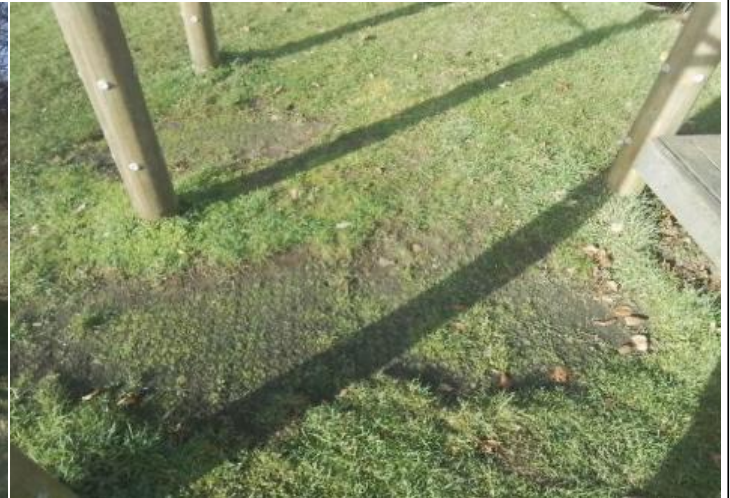
**Finding:** The grass mats are silted up, the soil is compacted and the area will become very slippery when the soil is wet. **Action:** Reinstate as required

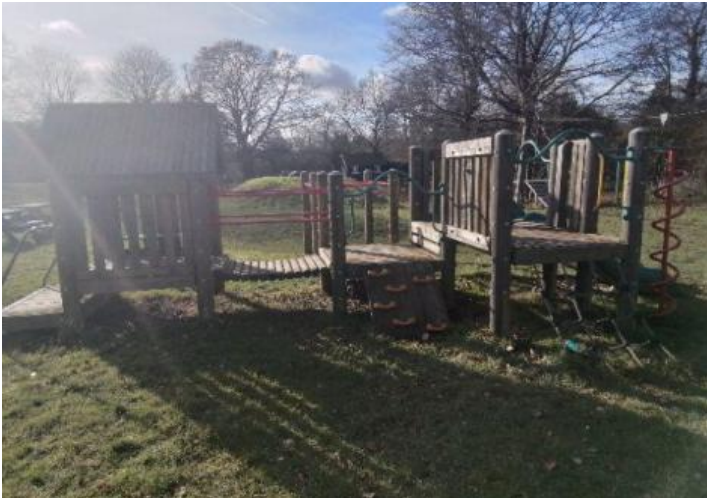
**Finding:** There are areas or parts of the timber on the structure that have rotted

**Action:** Replace all affected timbers

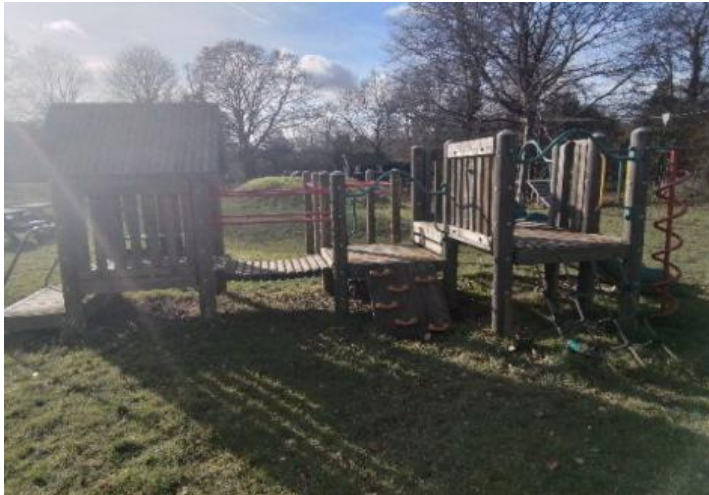
**Finding:** There is or are fixings missing on the item

**Action:** Replace all missing fixings

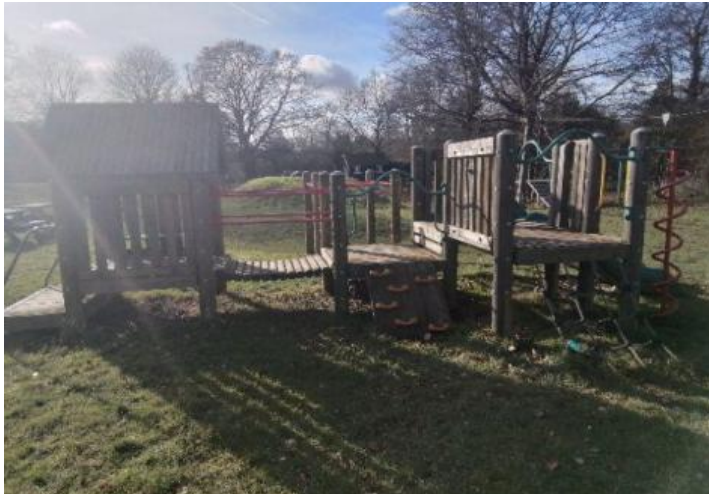
**Finding:** The end ferrule is missing from one rope on the cargo net

**Action:** Monitor - No remedial work recommended

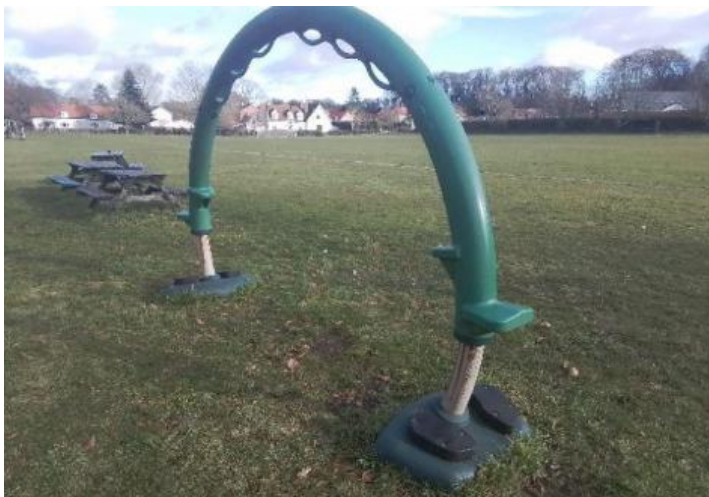
**Finding:** The buffers are wearing

**Action:** Monitor for any further deterioration and replace as required

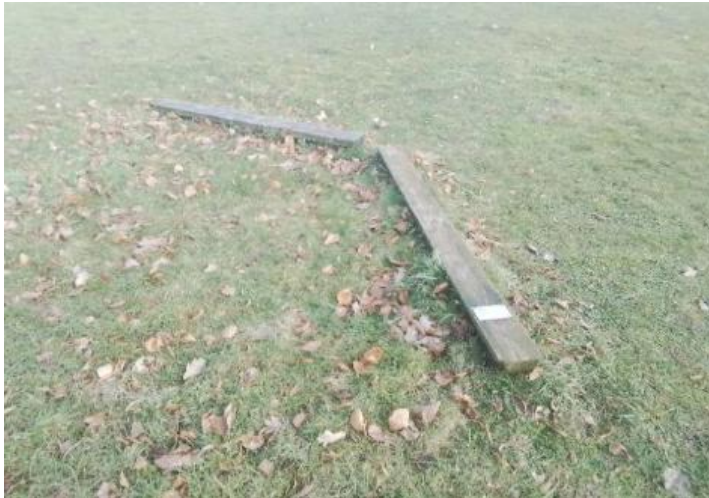
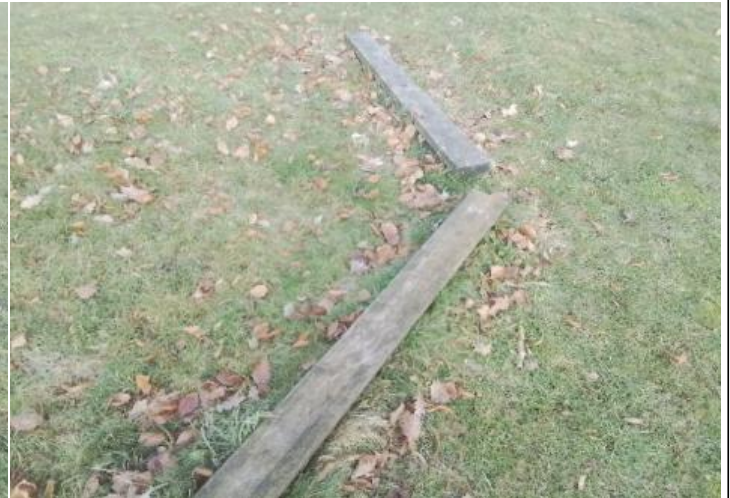
**Finding:** There is algae or moss on the surface of the equipment

**Action:** Clean and treat appropriately

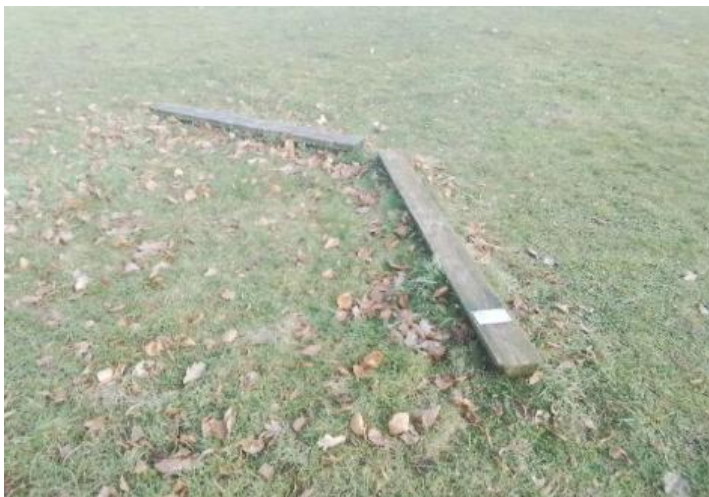
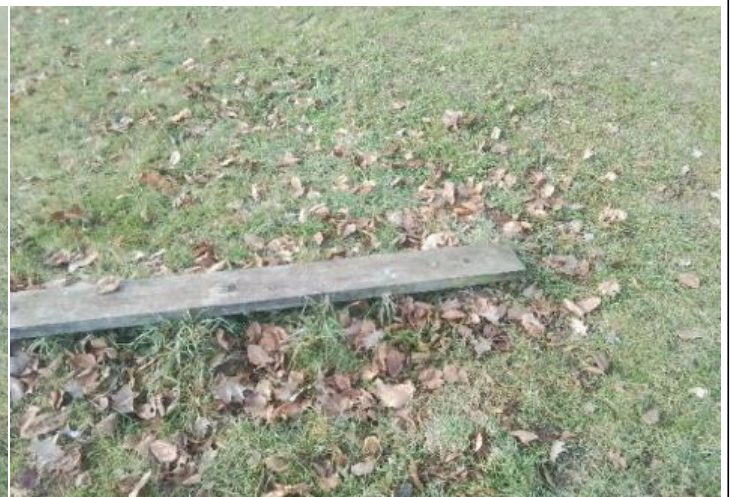
**Finding:** There is weed / vegetation growth on, between, or around the edges of the surfacing

**Action:** Remove weed / vegetation growth

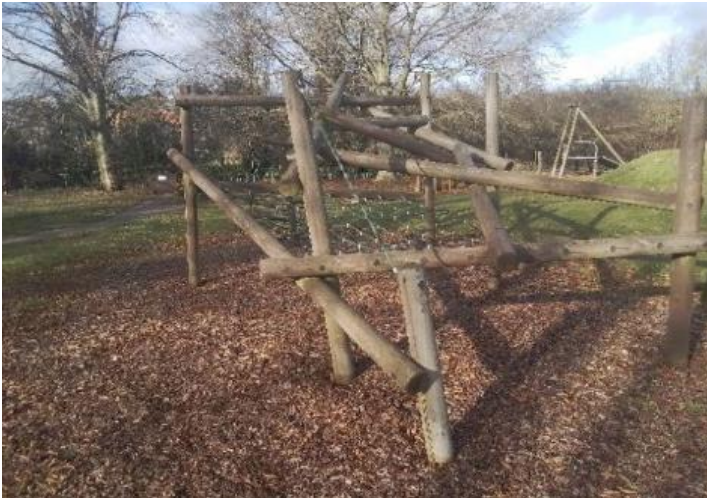
**Finding:** The connecting links are in excess of 8.6mm and less than 12mm and fail the requirements of BS EN 1176 Part 1; clause 4.2.13, Chains

**Action:** Monitor use and replace with compliant links at the next maintenance cycle

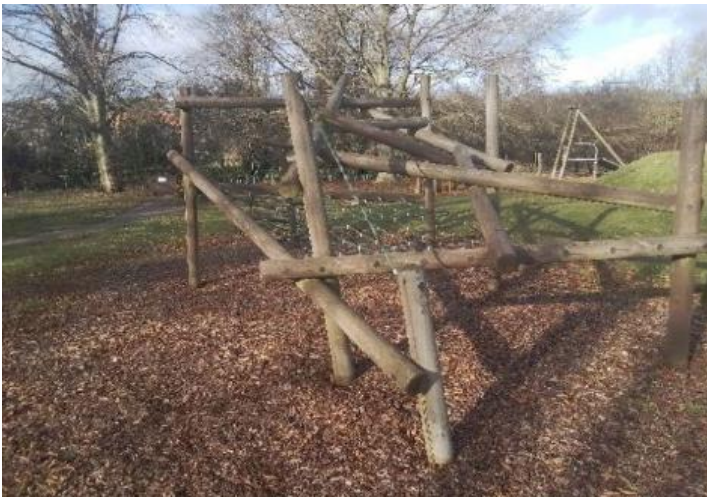
**Finding:** The timber has a number of splits/shakes or air cracks and this may affect the stability or allow water ingress which will accelerate the rotting process

**Action:** Monitor to ensure the splits do not cross through fixing points of the structure and/or cause any instability

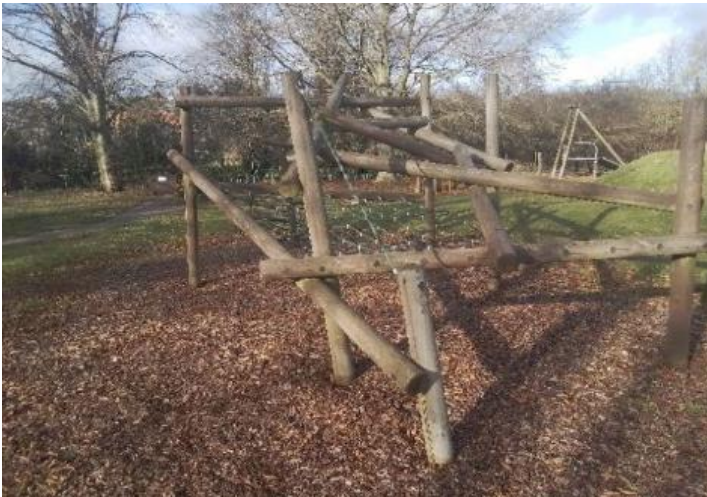
**Finding:** The ropes/nets are worn/damaged in places

**Action:** Monitor for any further deterioration and repair or replace as required

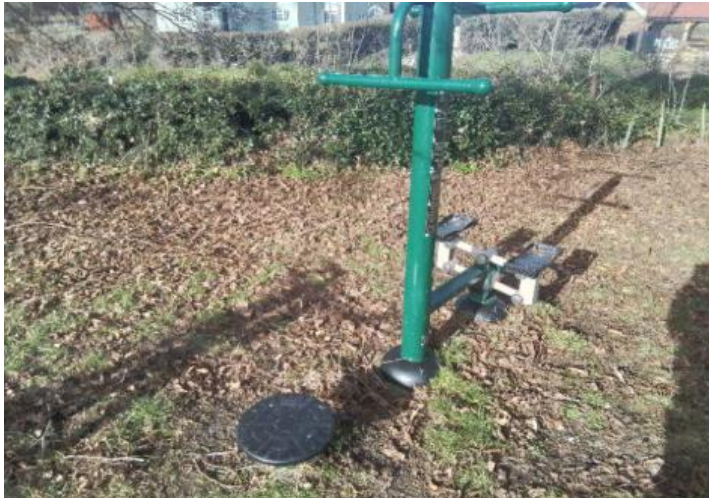
**Finding:** The deflection of the rotating user station exceeds the maximum 105 degrees required by BS EN 16630  
**Action:** Monitor - No remedial work recommended

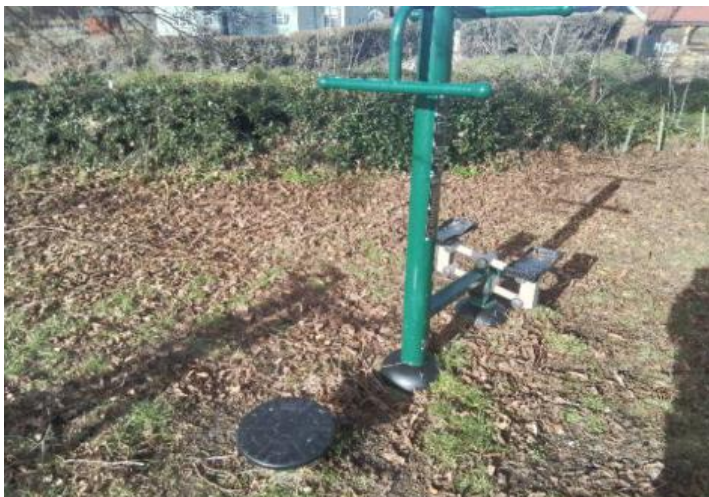
**Finding:** The rotating user station is not appropriately marked with a guideline of user direction and/or the original position as required by BS EN 16630  
**Action:** Monitor - No remedial work recommended

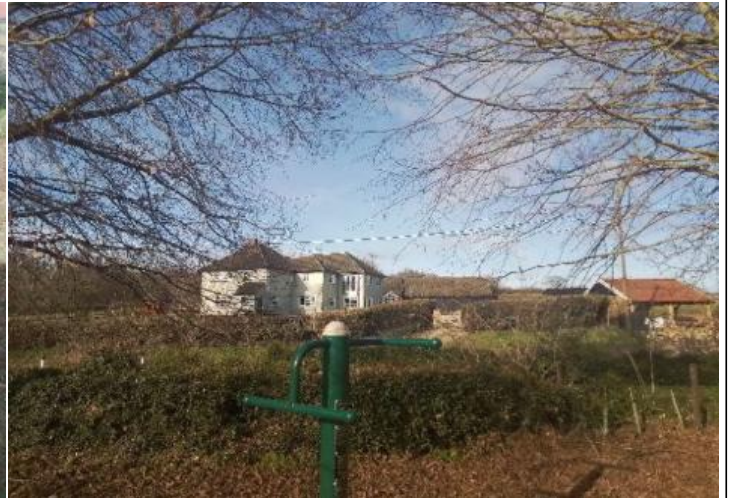
**Finding:** The tree canopy overhangs the equipment and is less than 2.0m away

**Action:** Lift tree canopy to ensure a minimum clearance of 2.0m from the equipment

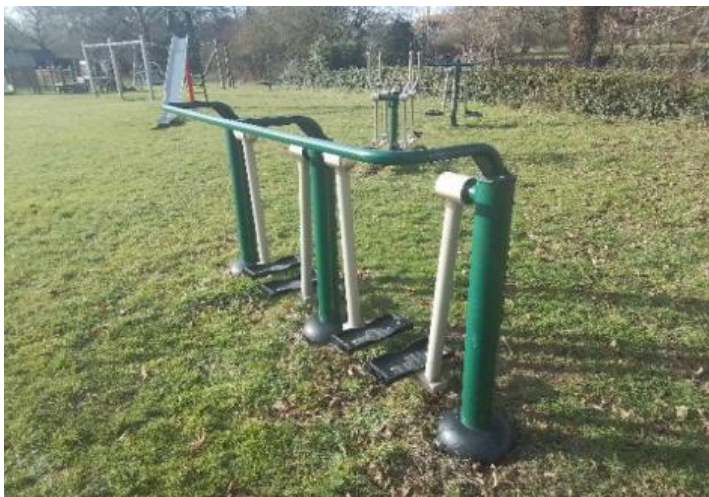
**Finding:** The swinging movement of the item exceeds the maximum 55 degrees from the vertical required by BS EN 16630

**Action:** Monitor - No remedial work recommended

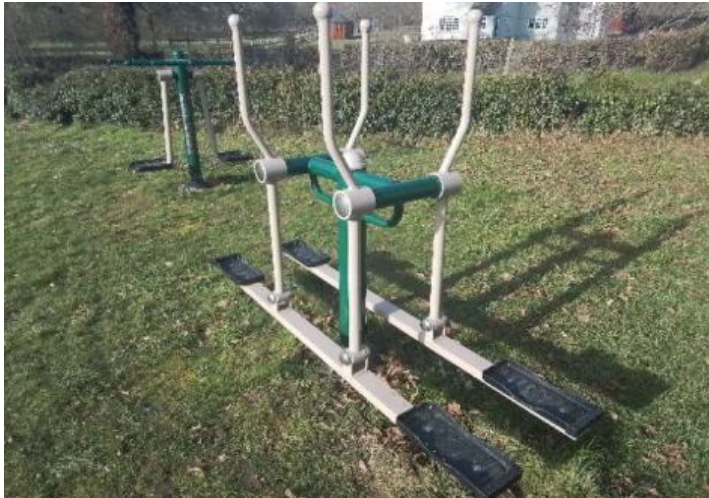
**Finding:** The swinging movement of the item exceeds the maximum 55 degrees from the vertical required by BS EN 16630

**Action:** Monitor - No remedial work recommended

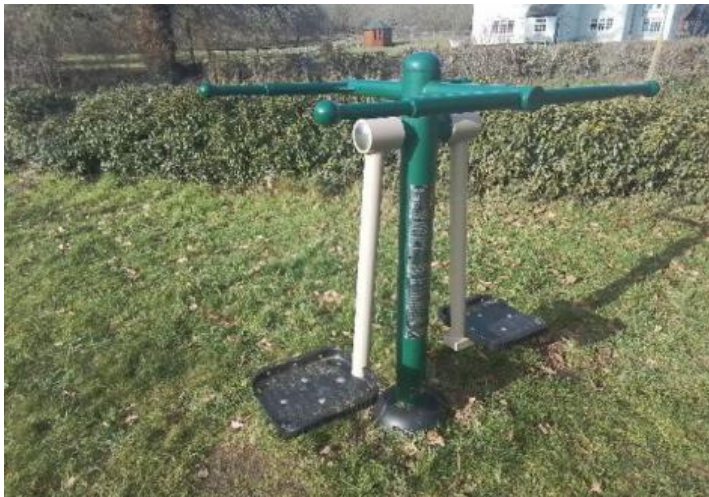
**Finding:** The swinging movement of the item exceeds the maximum 55 degrees from the vertical required by BS EN 16630

**Action:** Monitor - No remedial work recommended
