Technical Note No. 01

Project Title:	Recommended Lorry routes through Coddendam	Prepared by:	AB
Project Ref:	The RLRR 2021/22 - Coddendam	Reviewed by:	LB
Client:	Suffolk County Council	Status:	Approved
Subject:	HGV Compliance in and around Coddendam including recommendations	Date:	10/03/2023

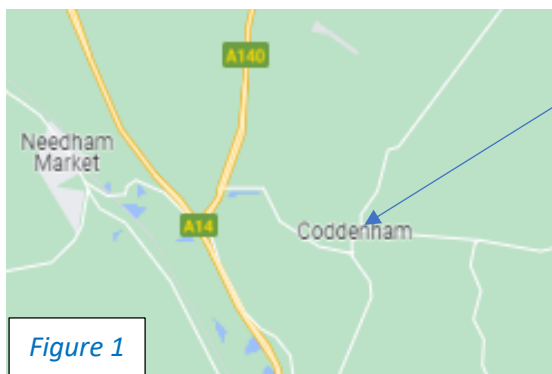
1.1. The village of Coddendam, Suffolk sits on the B1078 between the junction with the A140 in the west and the village of Clopton where the B1078 joins the B1079 in the east (*Figure 1*).

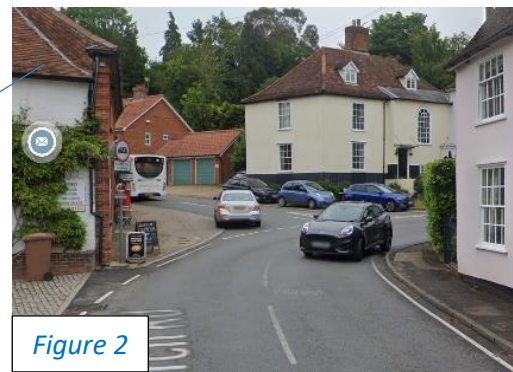
1.2. The B1078 route through Coddendam has some notable pinch points along the High Street, at Crown Corner (*Figure 2*) and along Church Road. These locations along the B1078 do become an issue when larger vehicle traffic converge in both directions and more frequently during morning and afternoon peak periods.

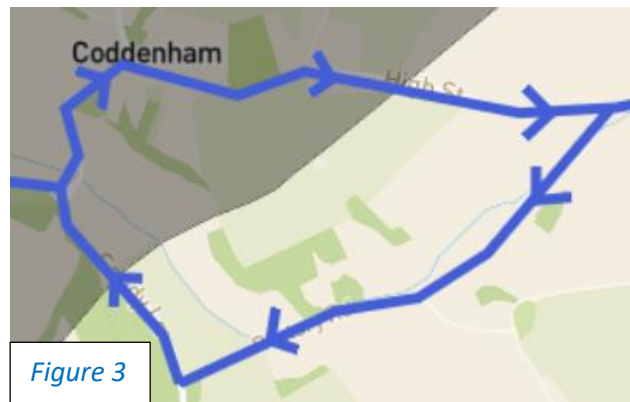
- 2.1. The B1078 acts as a zonal lorry distribution route as part of the [Recommended Lorry route map](#) between the A140 to the west and where it links to the A12 in the east at Lower Hacheston near Wickham Market.
- 2.2. Currently, this zonal lorry distribution route is recommended for HGVs to travel in an eastbound direction along the B1078 from the junction of Needham Road and Sandy Lane through Coddendam in conjunction with current weight restrictions. HGVs travelling westbound along the B1078 towards Coddendam are signed to travel along Rectory Road in a southwest direction, in accordance with the same weight restrictions and to avoid eastbound HGV traffic from Coddendam (*Figure 3*).

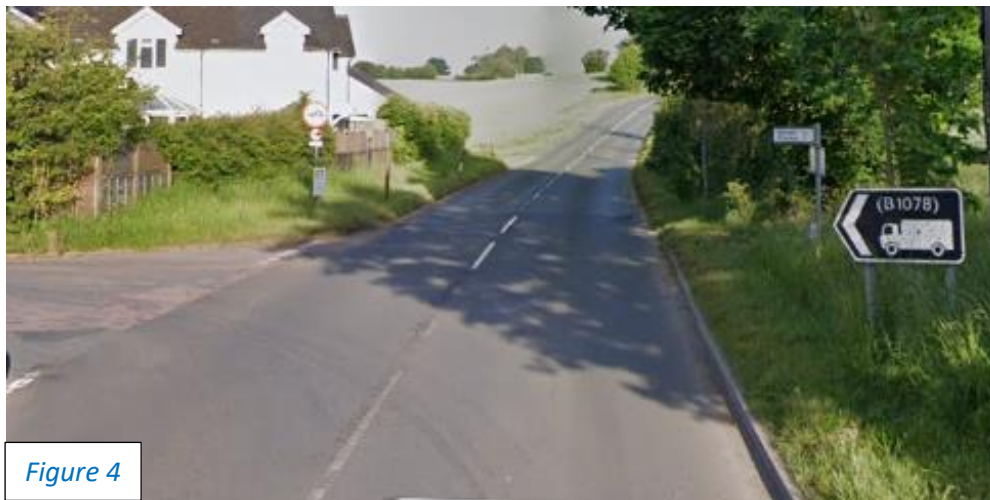
- 3.2. The first 7.5T restriction commences westbound along the B1078 at the Rectory Road Junction along the High Street towards the centre of Coddendam (*Figure 4*). This also includes regulatory signage for HGVs to turn left along Rectory Road in accordance with the current restriction.

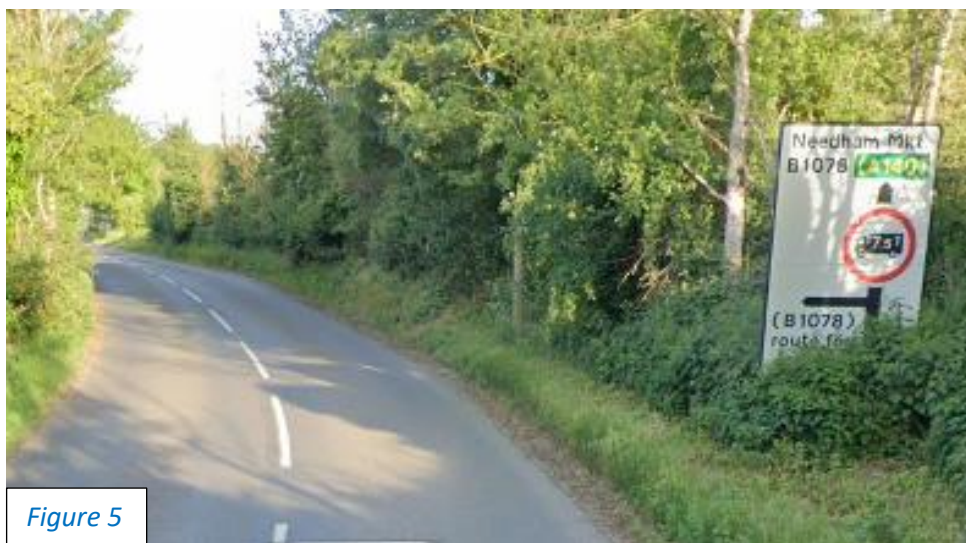
- 3.3. Below (*Figure 5*) shows the westbound advance signage along the B1078 towards the junction with Rectory Road.

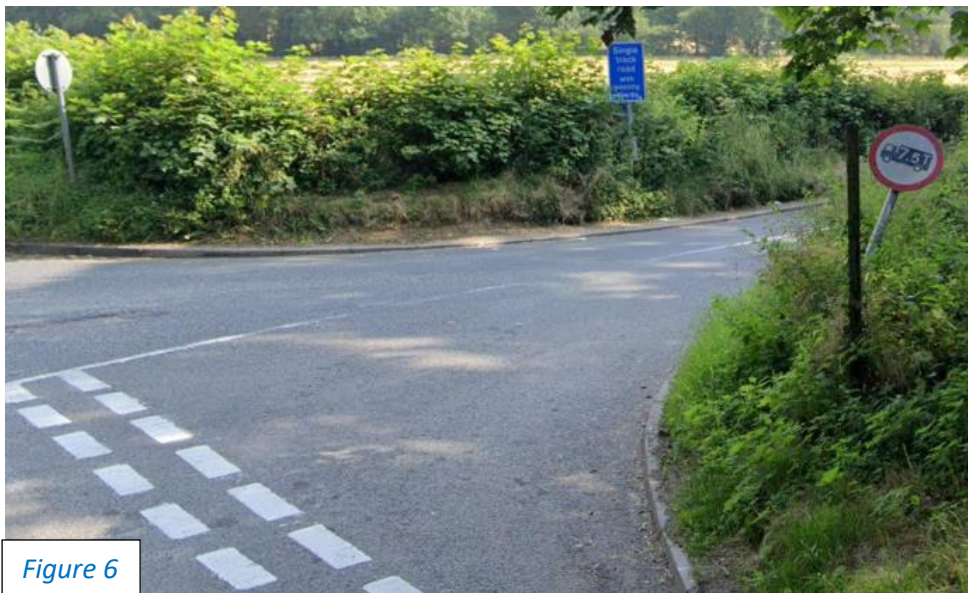
- 3.4. In accordance with the same TRO, the second 7.5T weight restriction commences at the junction of Rectory Road and Sandy Lane in the eastbound direction (*Figure 6*). There is also advanced signage to the south along Sandy Lane on the approach to the same junction (*Figure 7*).

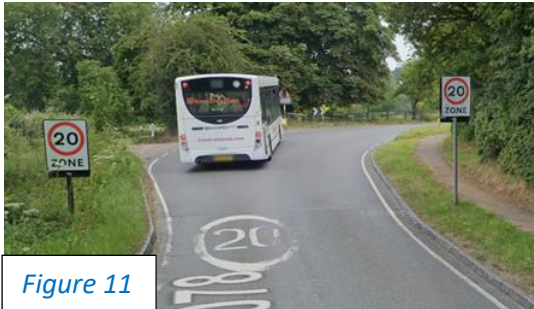
- 6.2. There is one 20mph speed limit along the B1078 which stretches between Church Road ([Figure 11](#)) and to the east along the High Street ([Figure 12](#)) which continues north along School Road. On the entry and exit to this 20mph speed limit zone, a 30mph speed limit is enforced.

- 6.3. The latest Safecam data from 2011 along the High Street, within the 20mph speed limit zone shows, a mean speed of 23.7mph with an 85%ile of 29mph.
- 6.4. In comparison, speed data taken from the traffic survey back in 2015 showed that over a 7-day period, the mean speed of all vehicle traffic within the 20mph speed limit zone was 22.9mph and the 85%ile was 29.2mph.

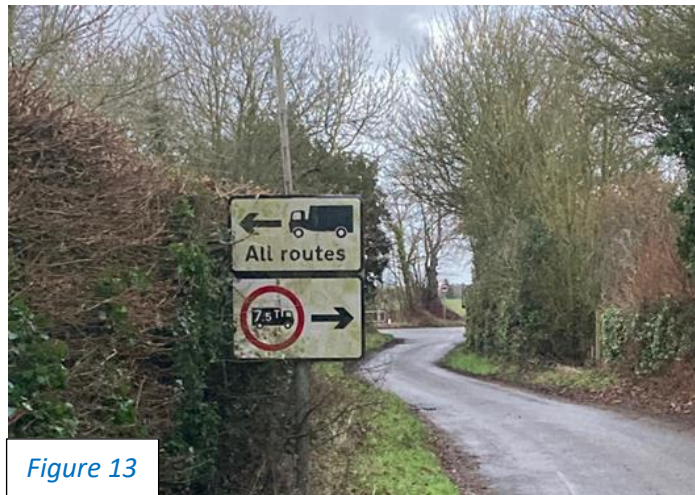
- 7.2 Also, after reviewing the signage in relation to the current weight restrictions associated with the Recommended Lorry route, there is potential to improve signage around junctions to improve the consistency and promotion of the Recommended Lorry routes in and around Coddendam. This is particularly evident when advising HGVs reaching Coddendam via the A140 and Needham Road, in advance of Rectory Road along the B1078 and approaching the B1078 via Cooper Road (*Figure 13*)
